This boiler was too small for inspection

An investigation into a boiler explosion by State Boiler Inspectors David Gonsoski and Tom Boyle and insurance company inspector John Glynn

The following investigation report is for a 1960 Weil McClain hot water heating boiler (pictured below) that had a BTU input of 625,000. This boiler accident happened in February 2013.

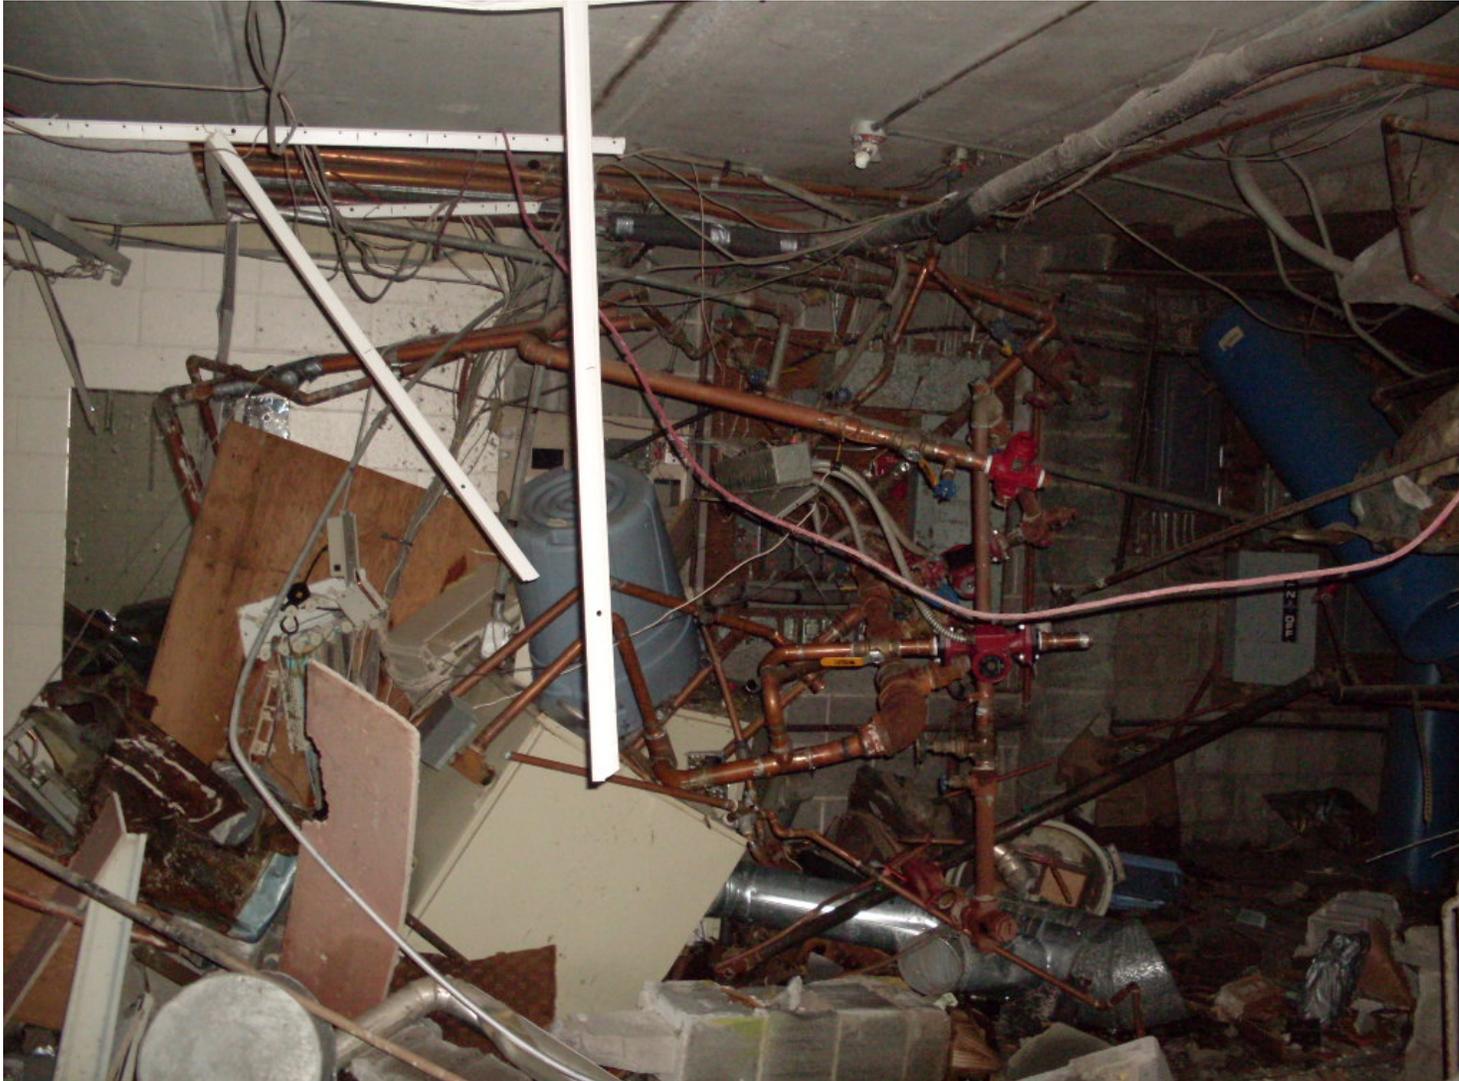
This image shows the condition of the boiler room after the explosion.

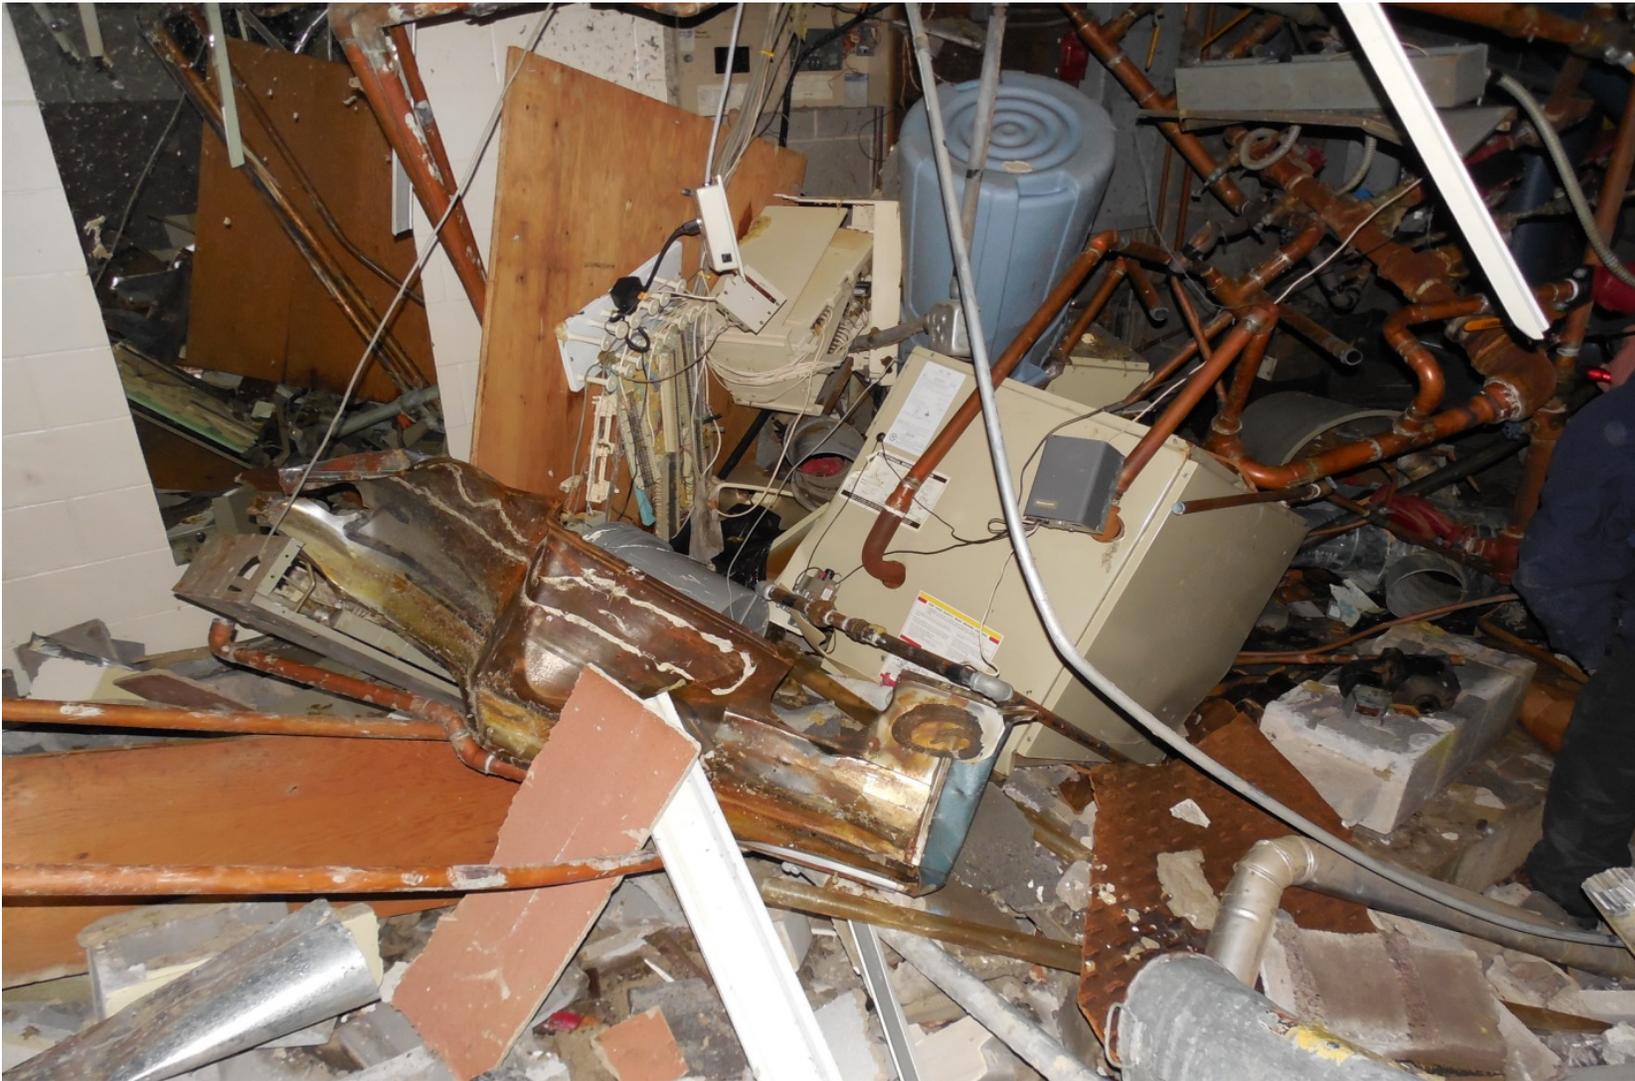
This photo shows the two small, newer boilers in the boiler room now relocated approximately 12 feet from their original location.

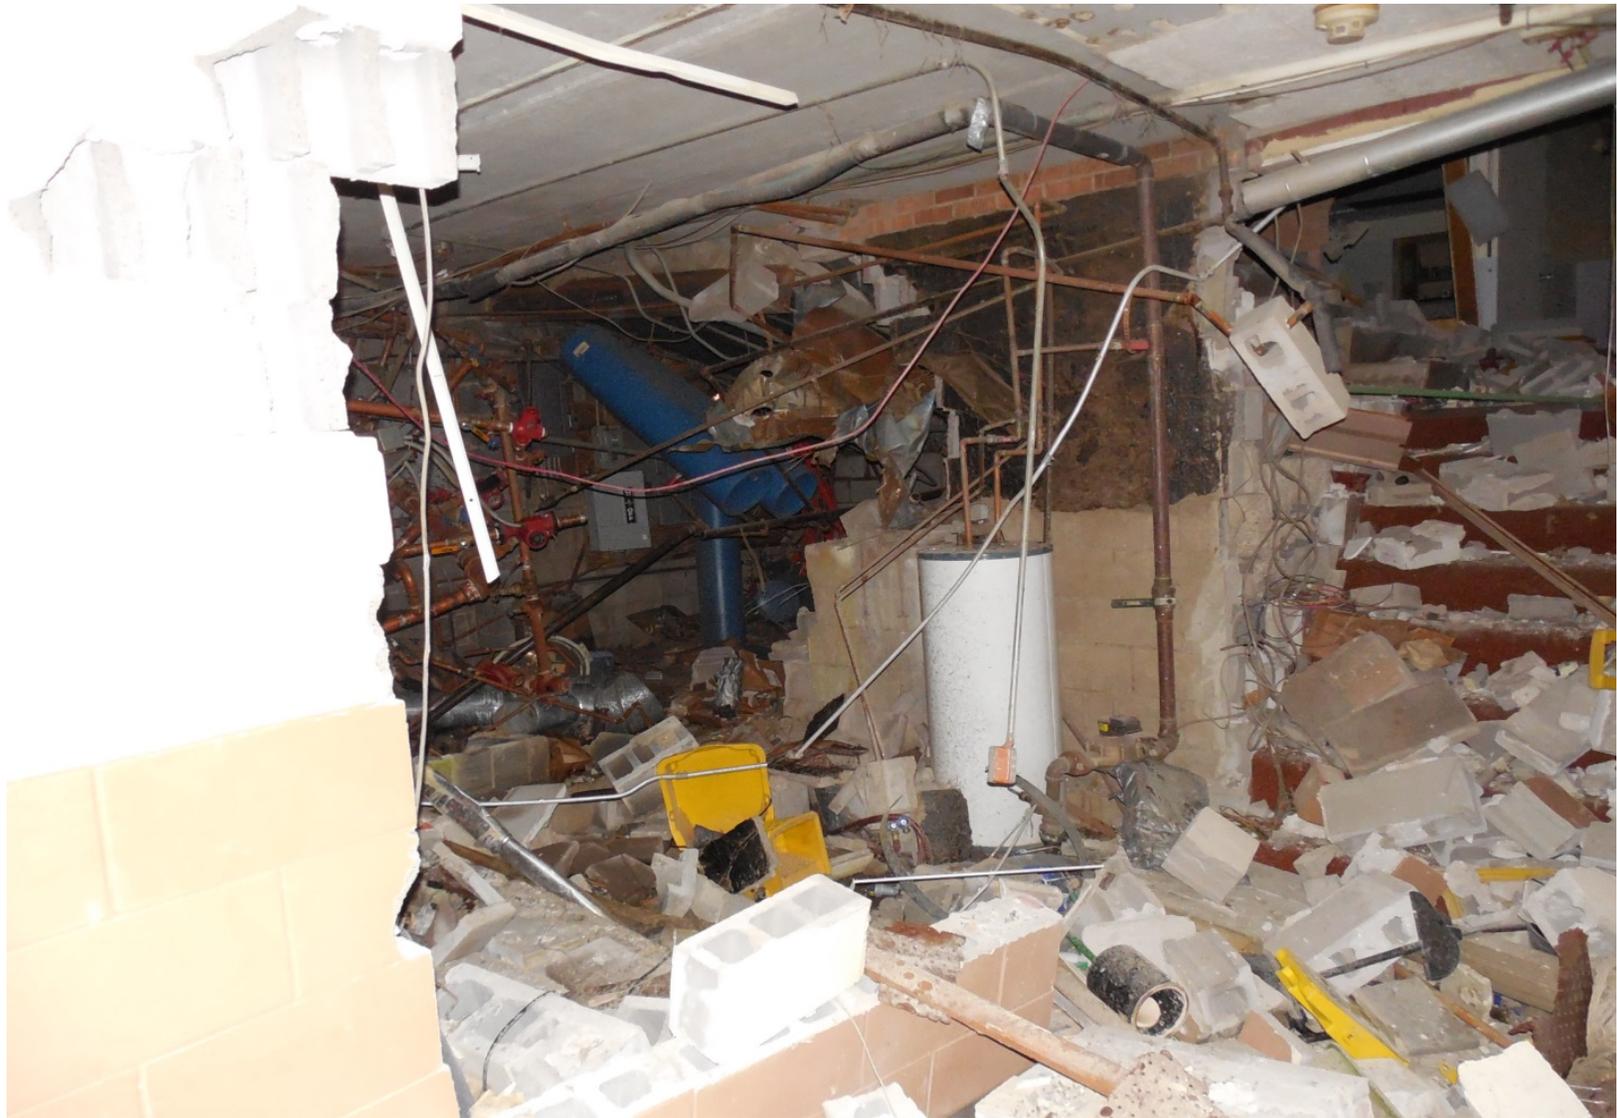
This picture shows what is left of the wall that separated the boiler room from the north/south hallway.

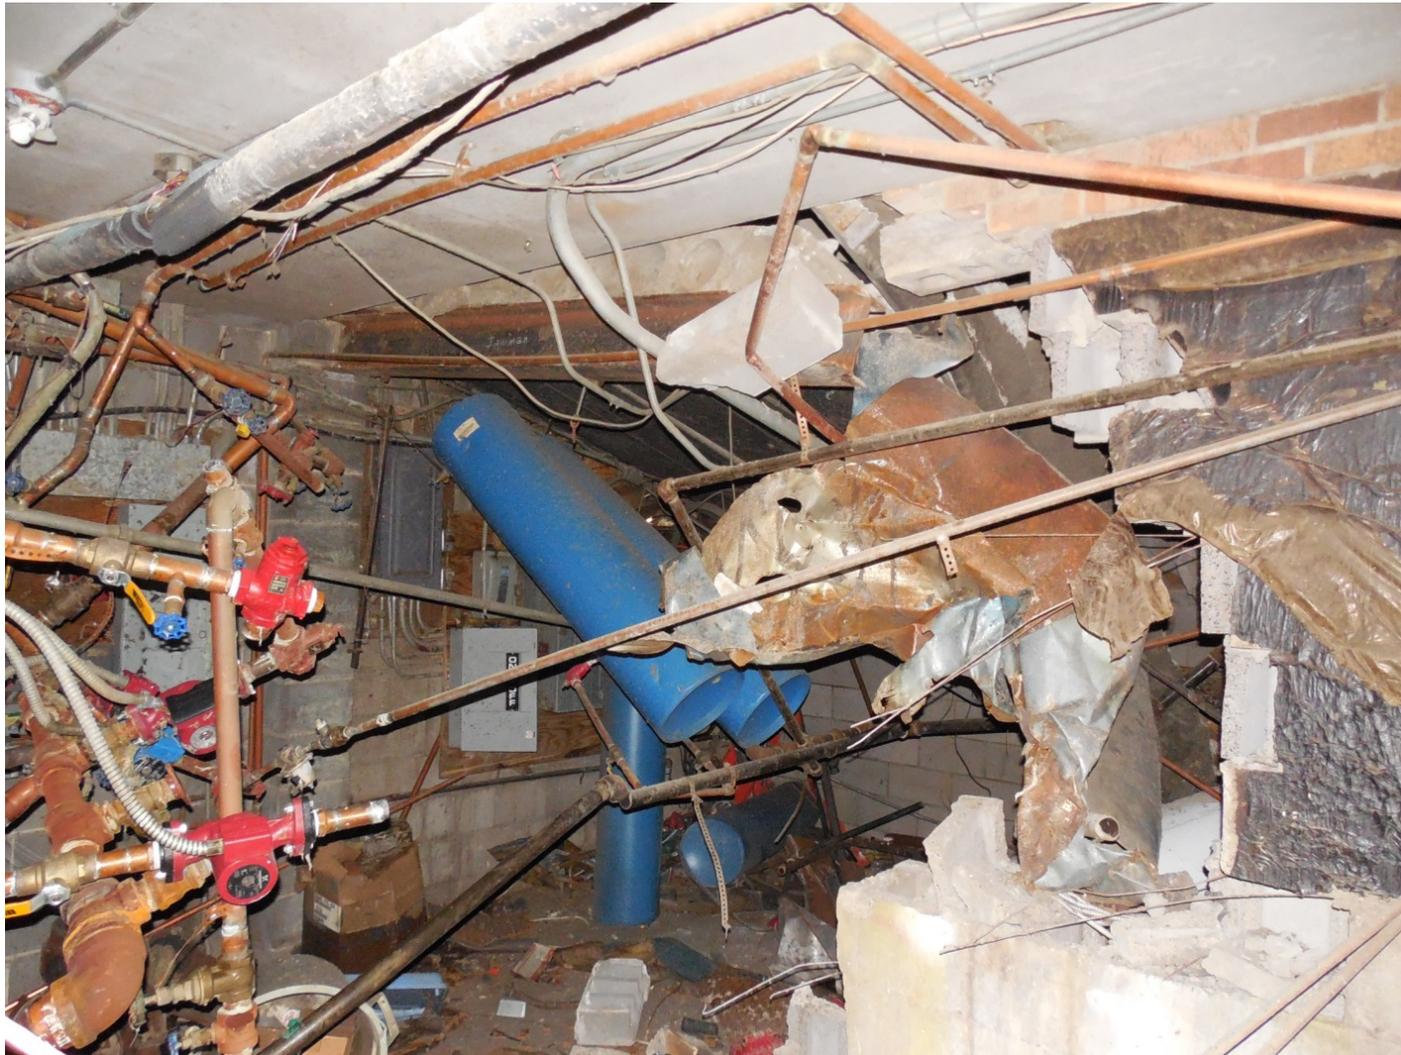
This image is looking further into the back of the boiler room where the Weil McClain boiler was located. Notice the destroyed I-beams and concrete in the ceiling. The piece of light blue and rusty metal in the front of the picture is part of the boiler skin/shell.

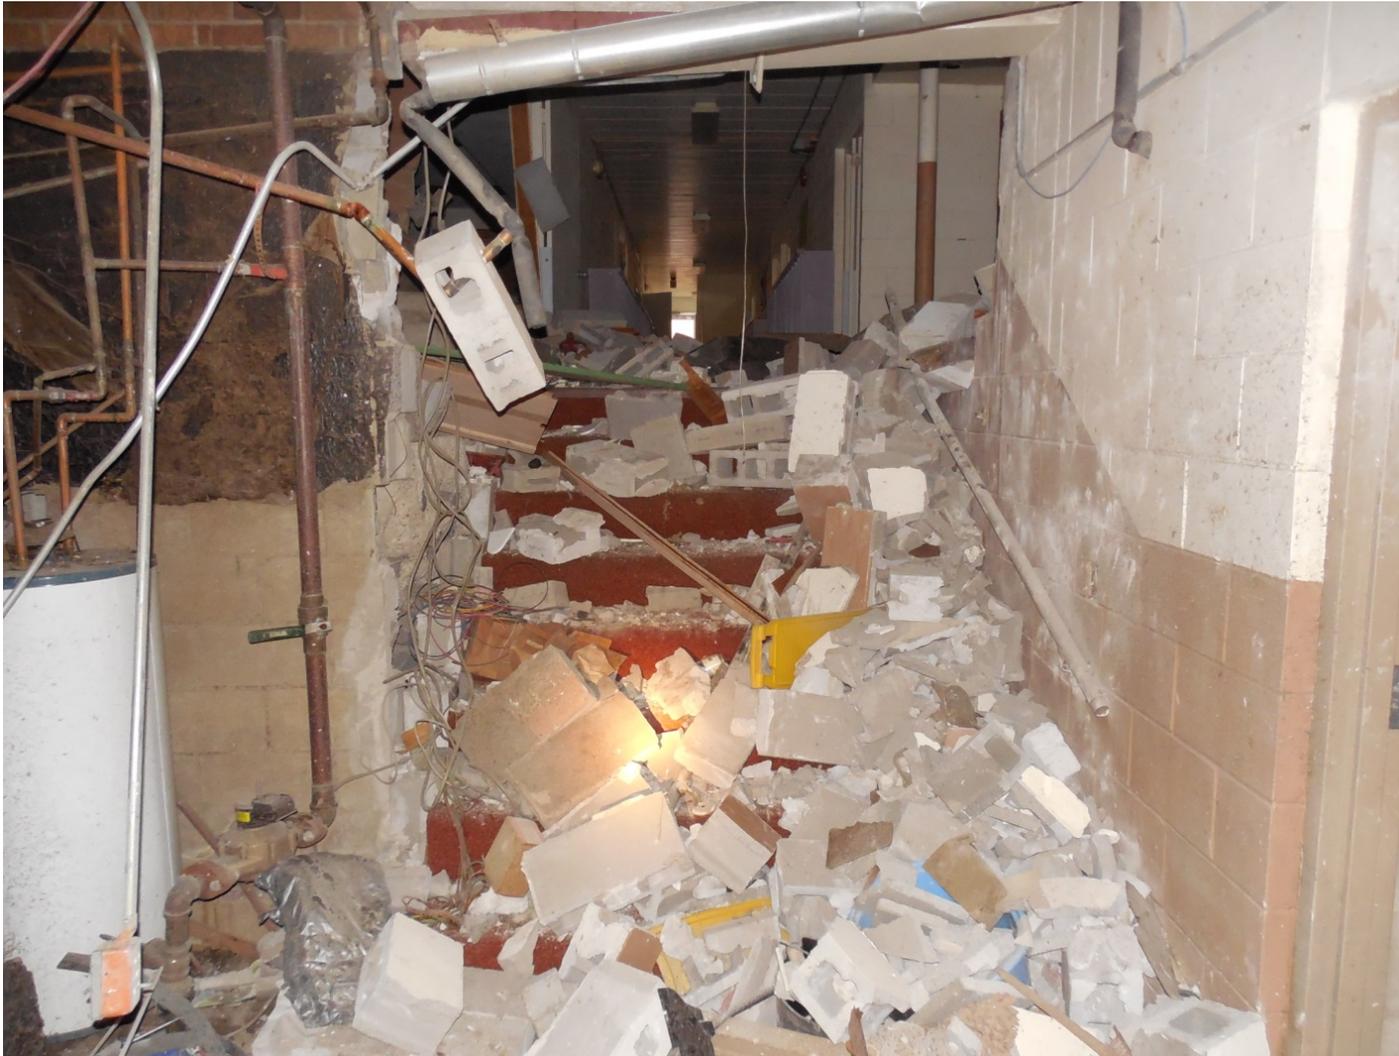
This image is looking south in the north/south hallway. Notice the white marks on the right wall from the cement blocks of the left wall hitting the right wall. The doorway on the far right is the door to the pantry. The water heater on the left is in the boiler room and was behind the wall that was disintegrated.

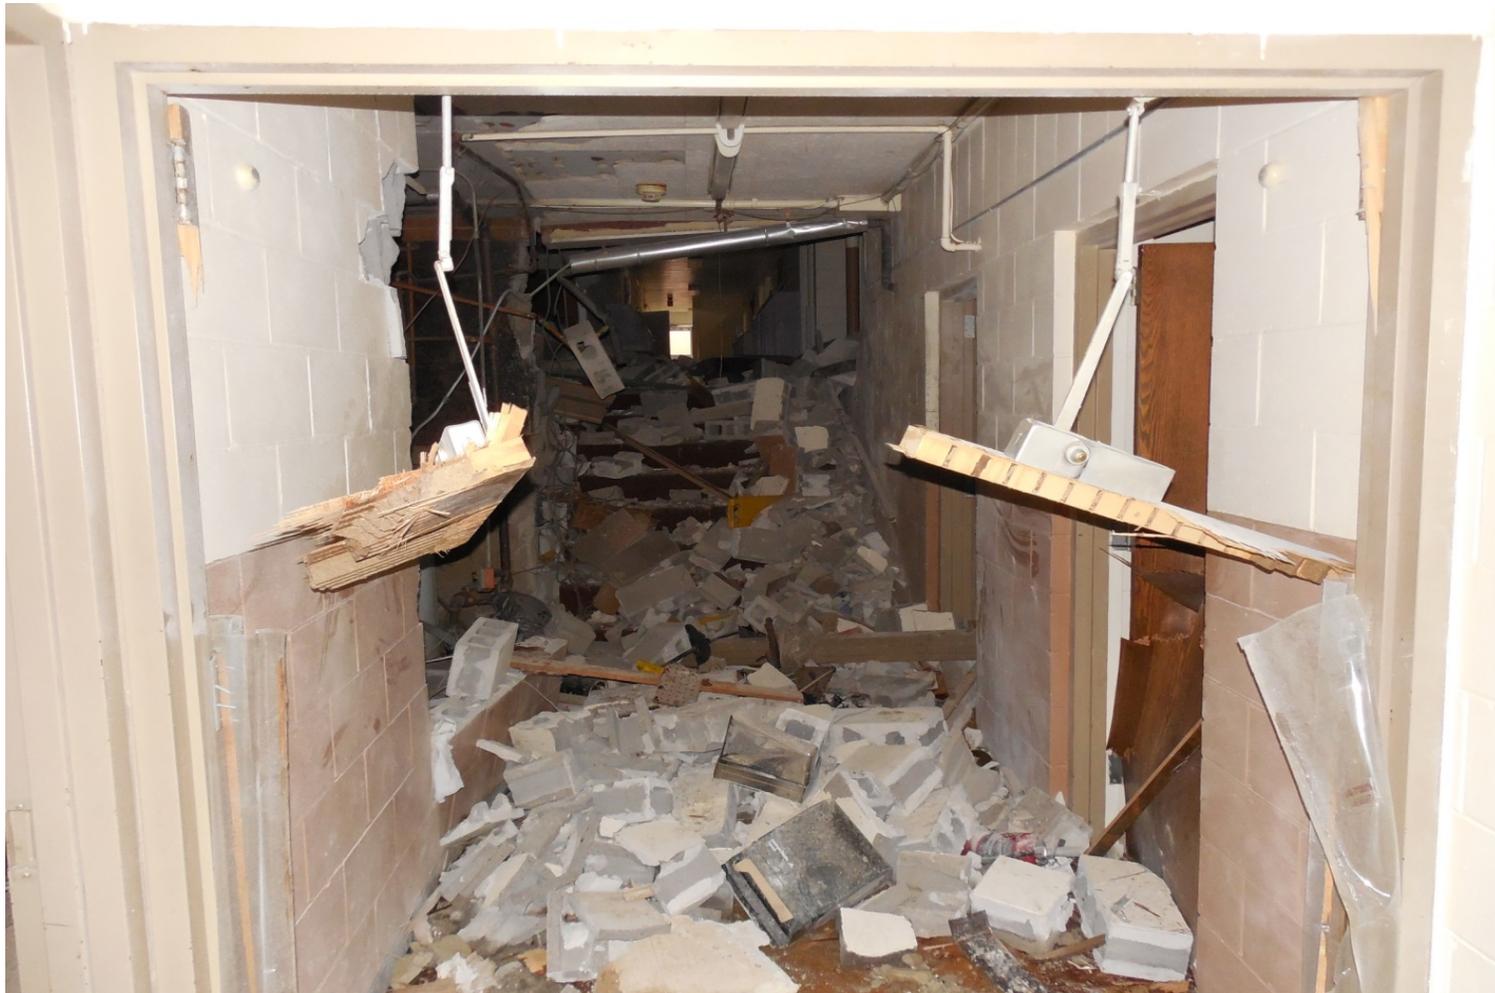
This image is looking south down the north/south hallway. The first door on the right is the kitchen entrance door. The second door on the right is the pantry entrance door. The large opening on the left is where the boiler room door was located, the first door on the left is the entrance to the bathroom, and the two things hanging from the ceiling near the front of the picture are the door closers for the double doors.

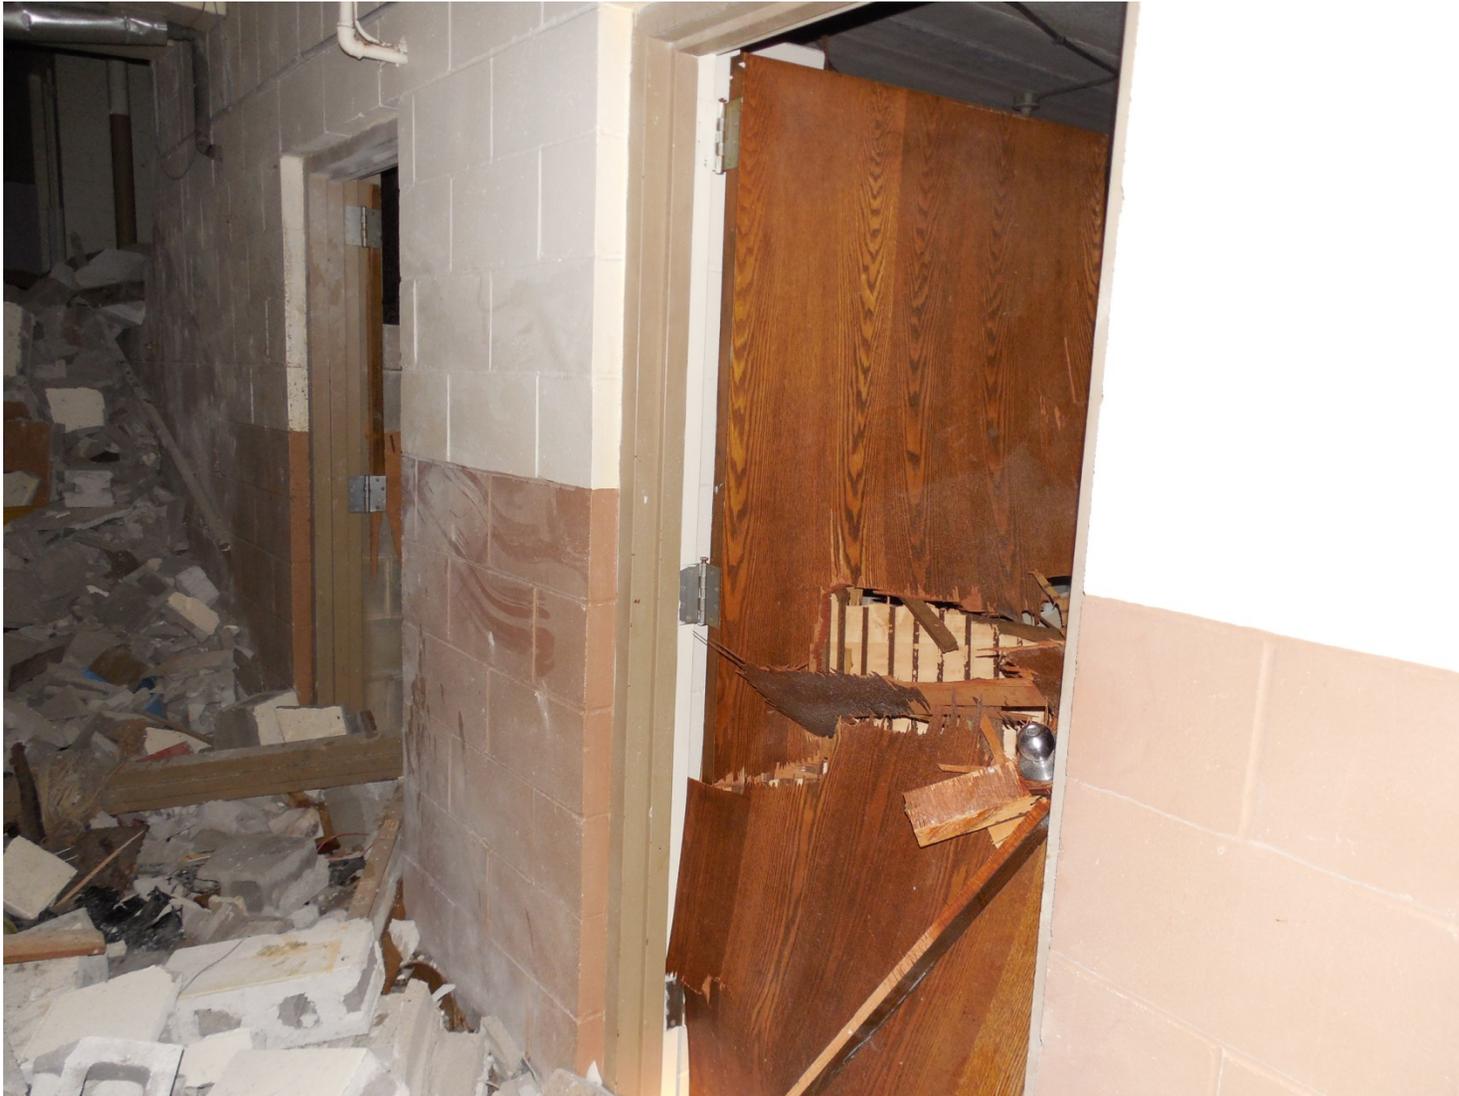
Here is a different view of the north/south hallway from the north looking at the kitchen entry door that was smashed by concrete block projectiles.

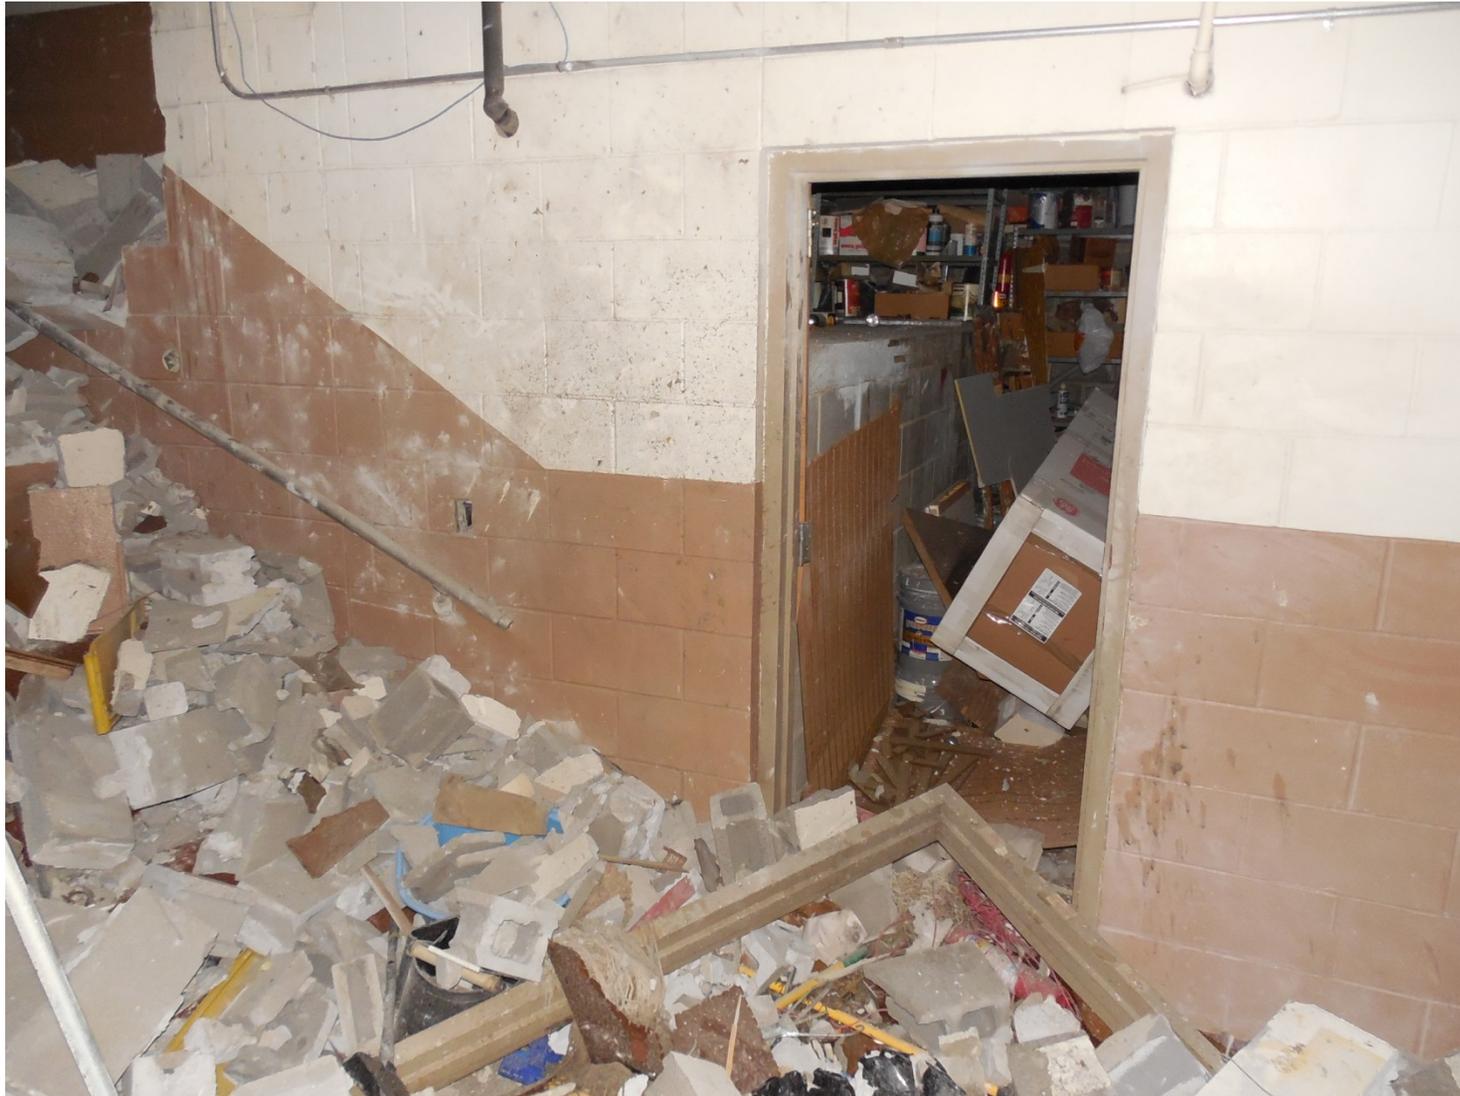
This view is looking from the boiler room into the pantry. Notice the pantry door is completely gone, and the frame from the boiler room door is lying in the rubble on the floor.

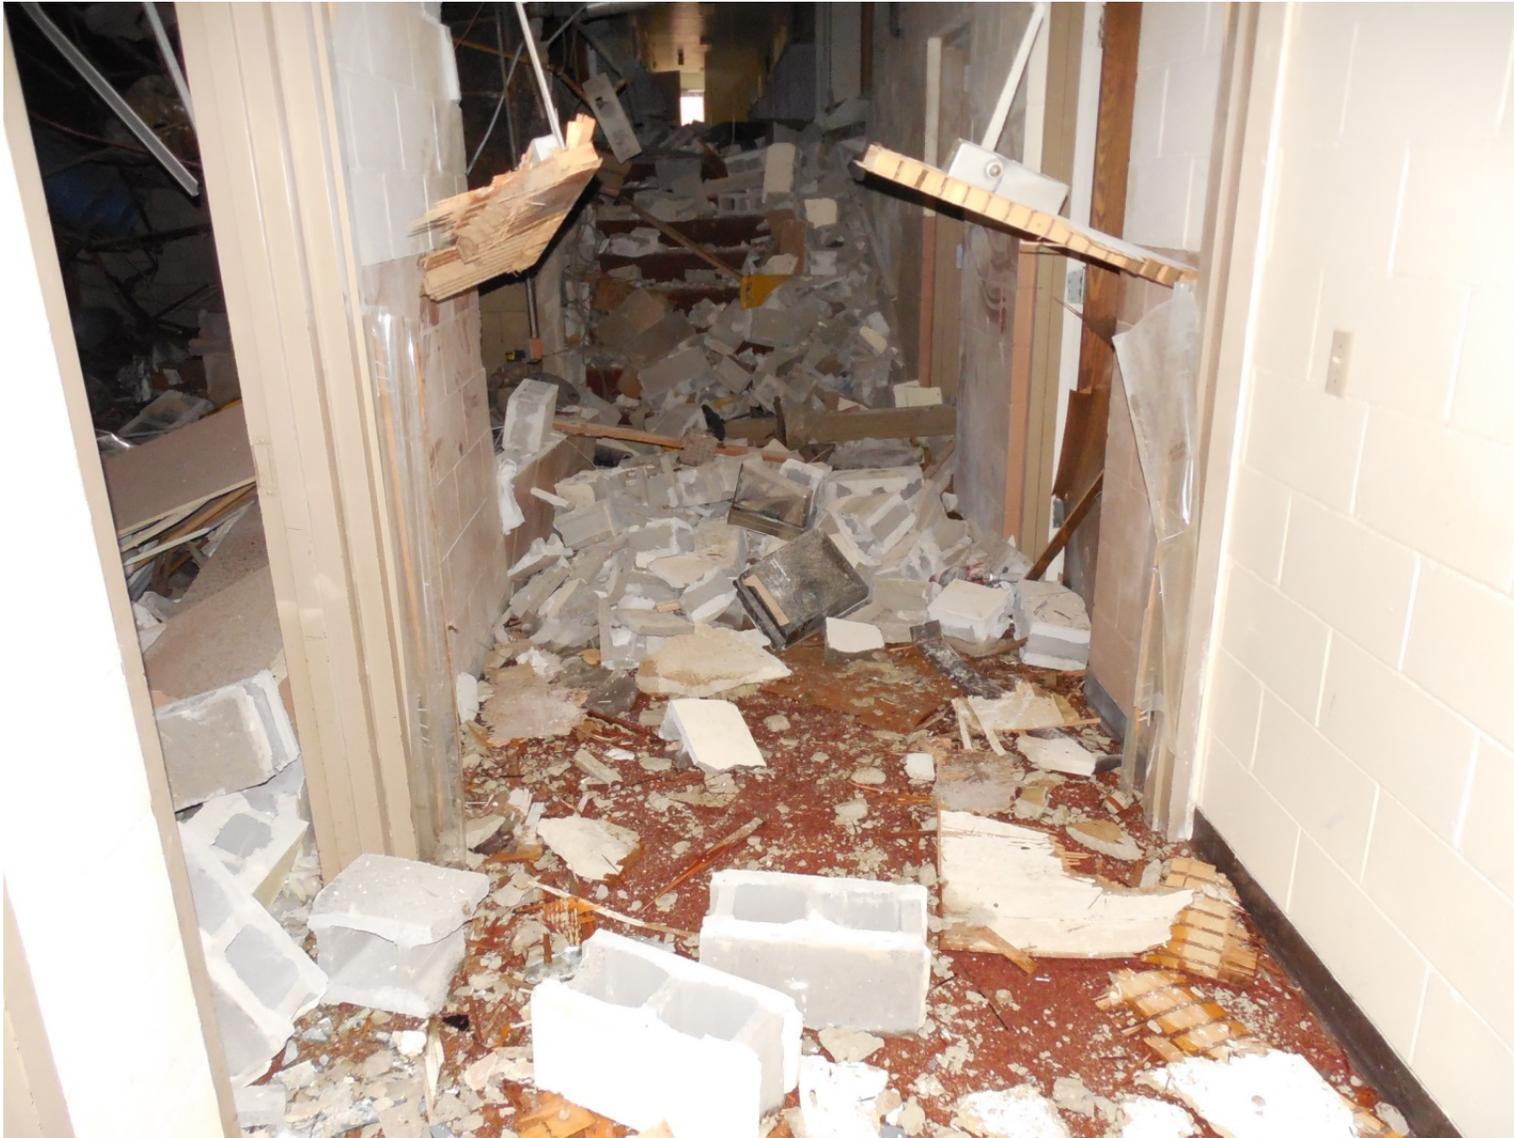
This image is looking south in the north/south hallway. The entrance on the left is the entrance to the bathroom.

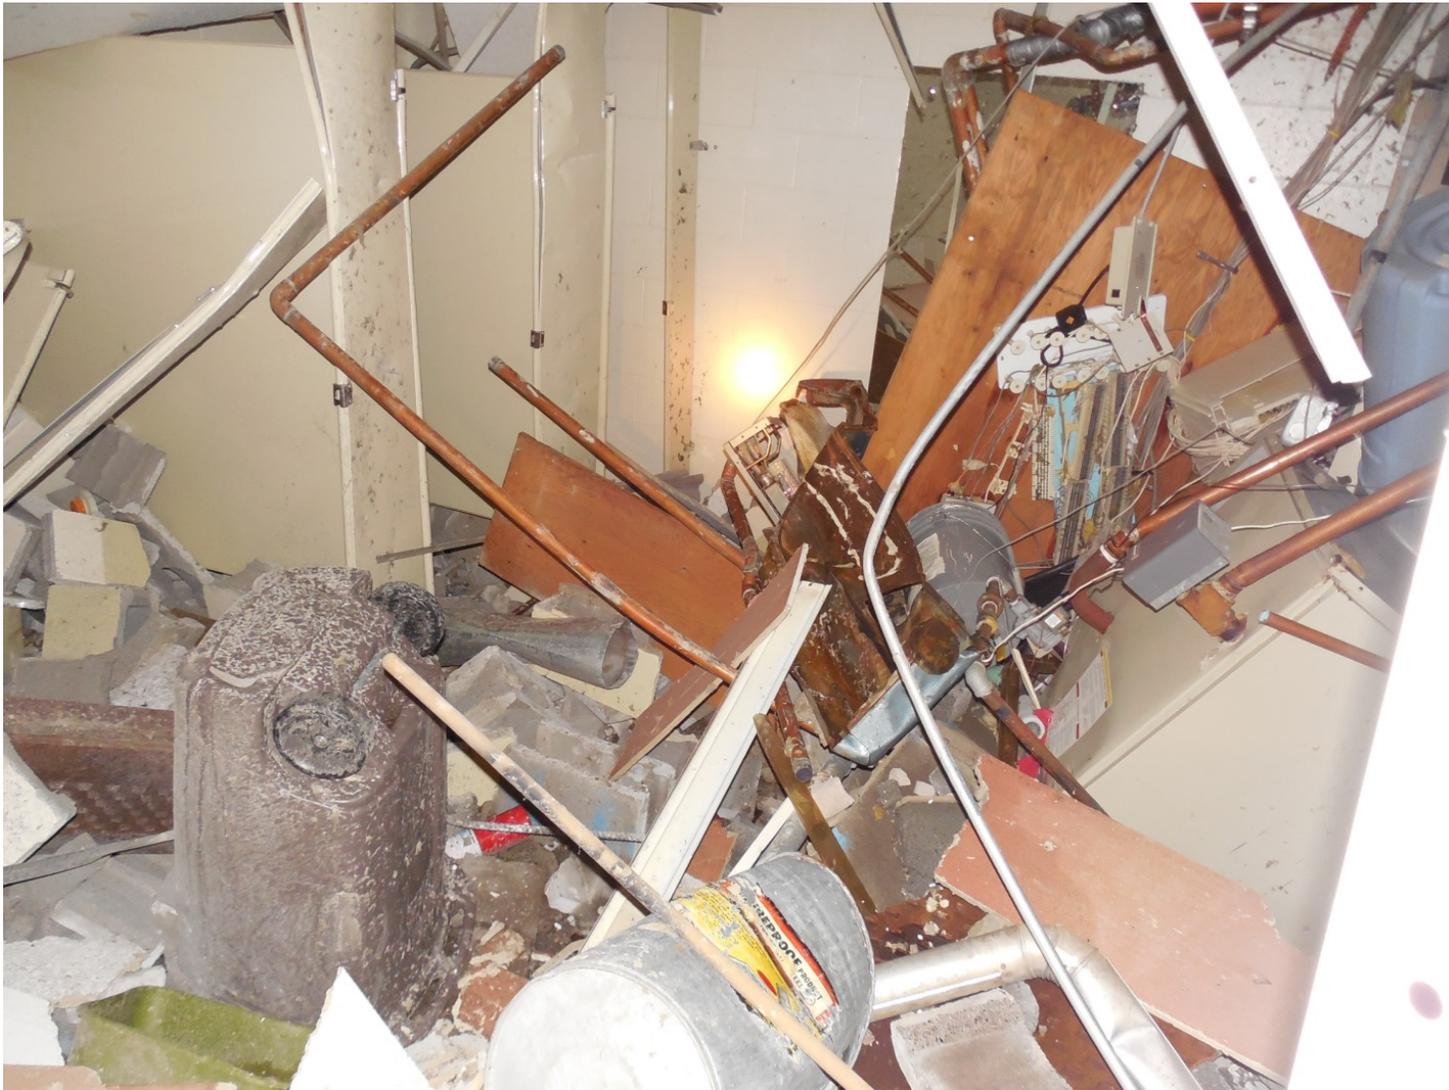
This image looks at the damage in bathroom from hallway near boiler room entrance. Notice the destruction of the bathroom stalls. These stalls were located 18 feet away from the boiler and behind a six-inch-thick concrete block wall.

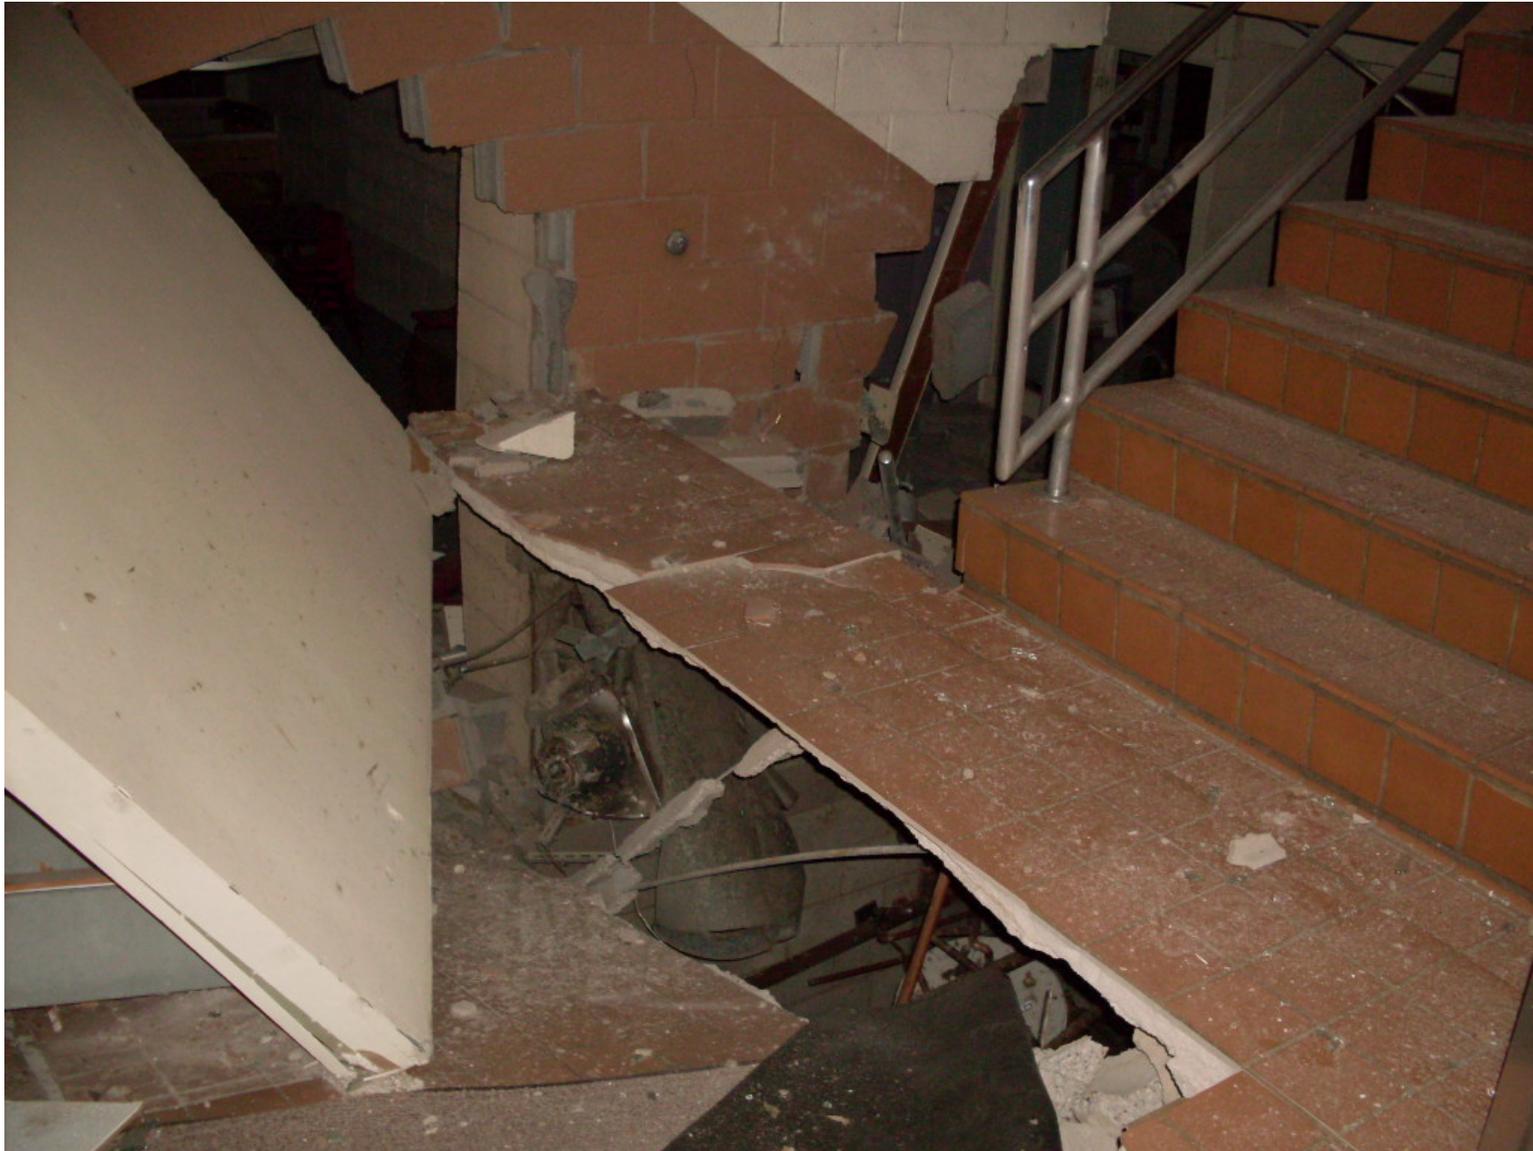
The first floor above the boiler room also received extensive damage.

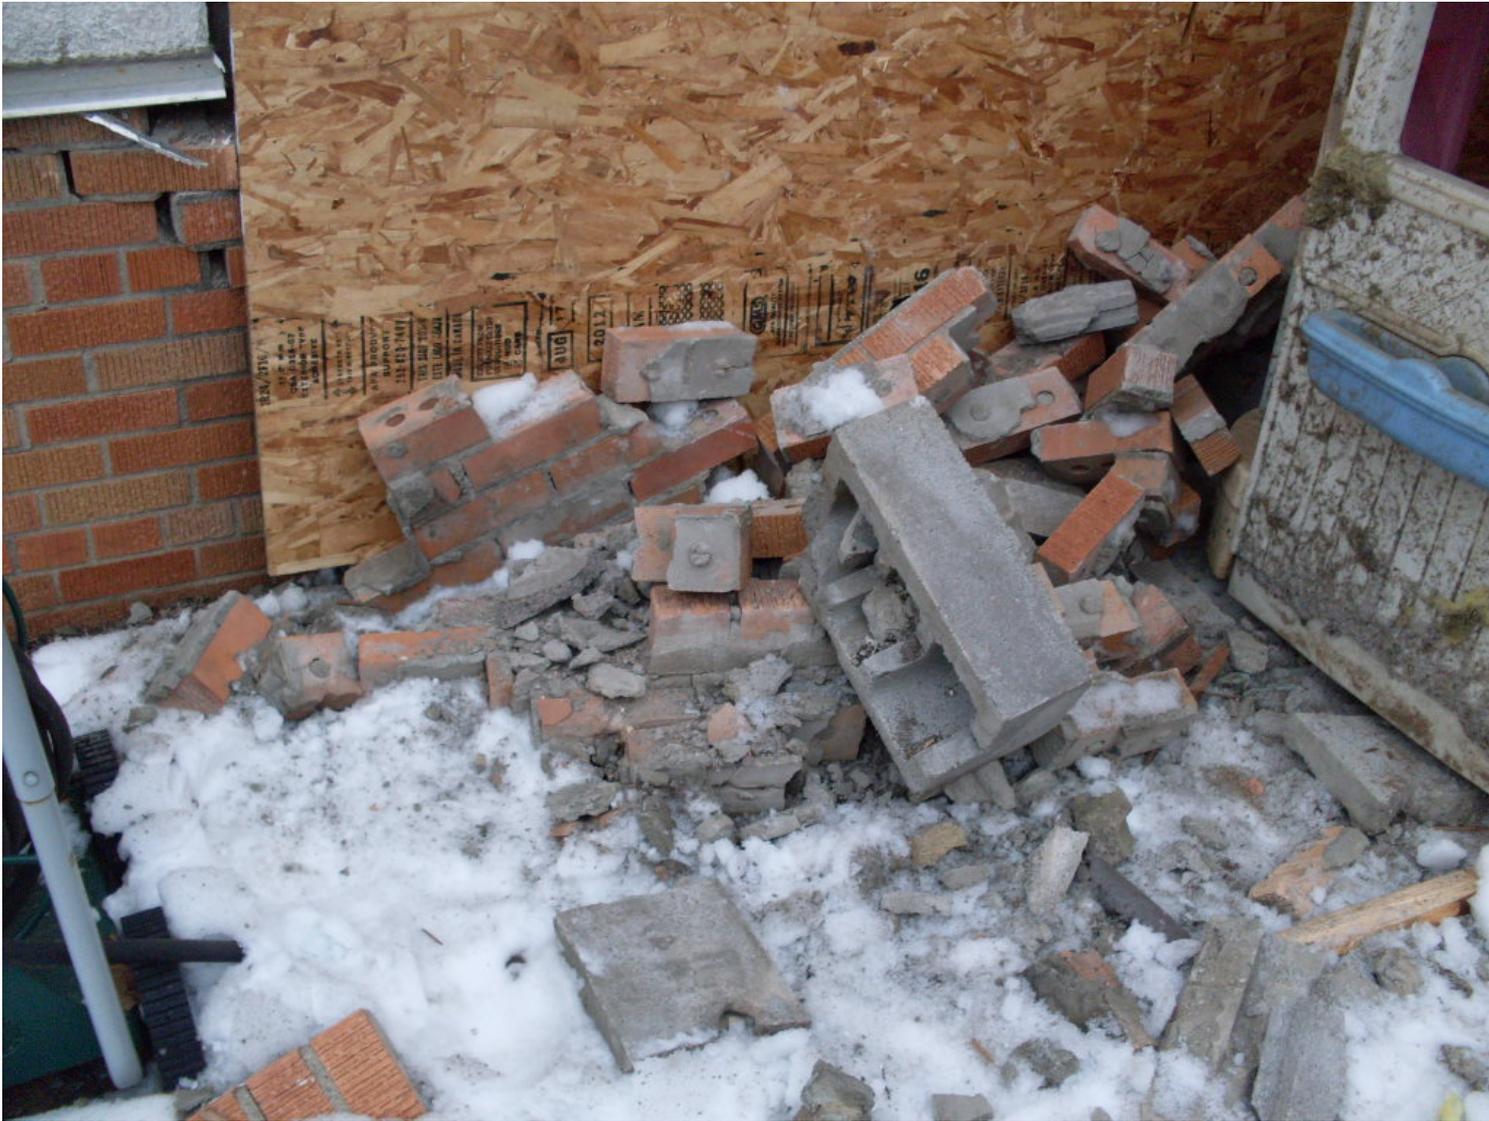
Here is the kitchen exterior wall.

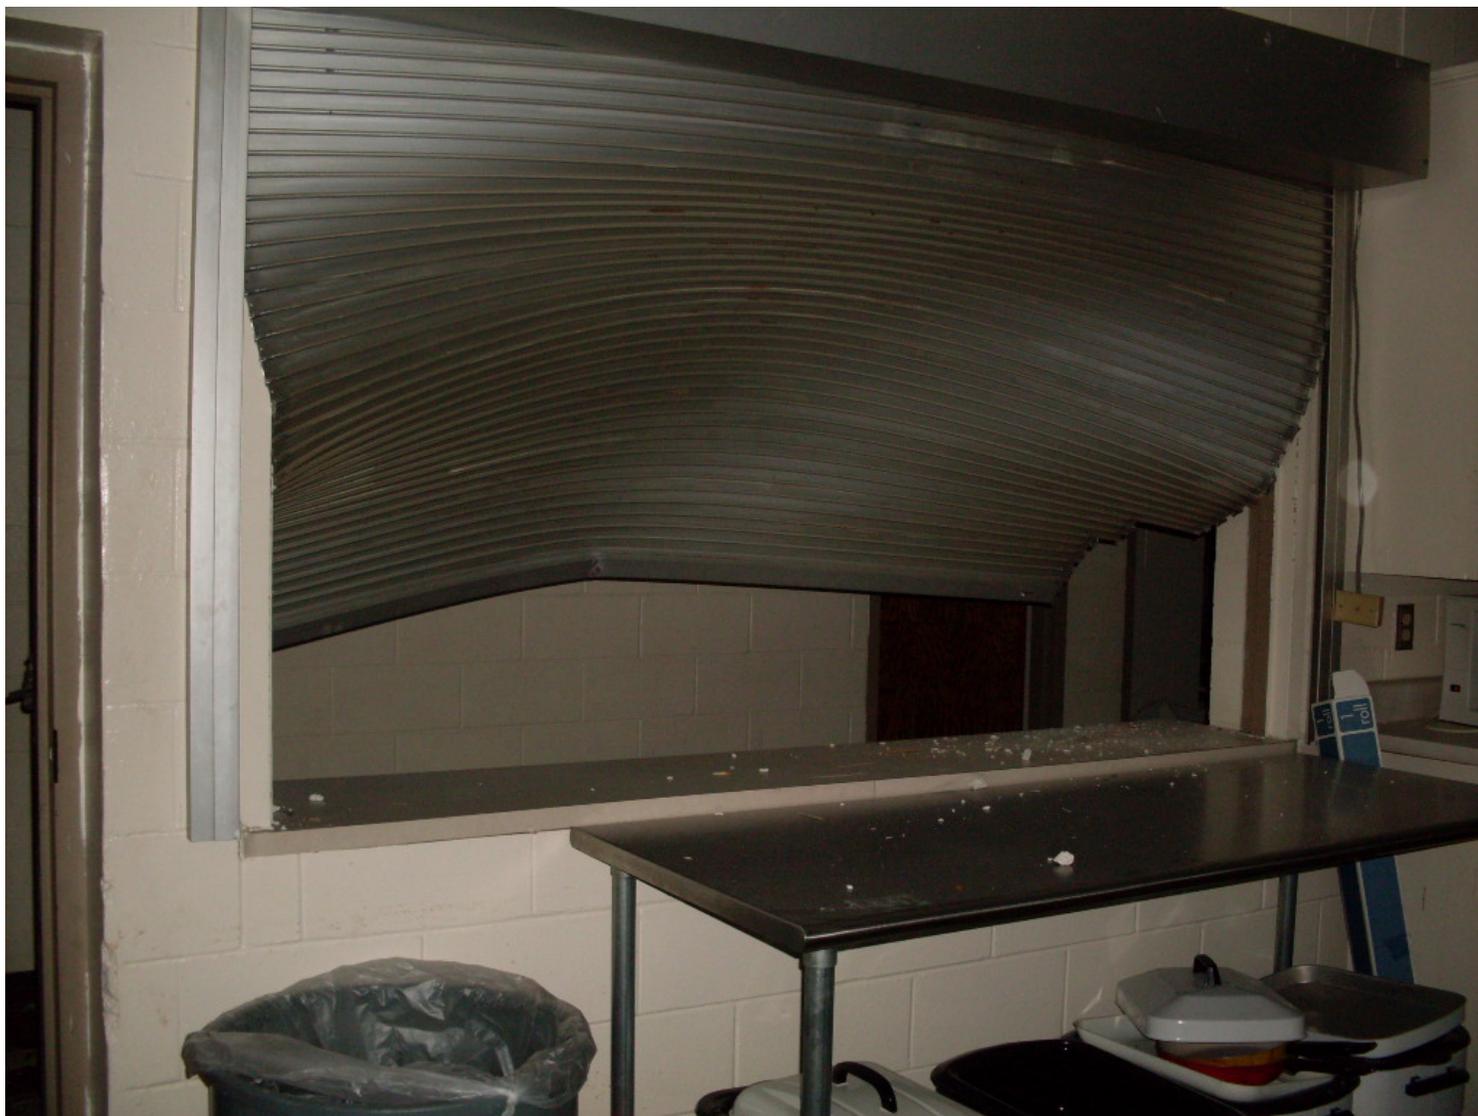
A photo of the damaged roll-up doors for the kitchen.
