This boiler was too small for inspection

An investigation into a boiler explosion by State Boiler Inspectors David Gonsoski and Tom Boyle and insurance company inspector John Glynn

The following investigation report is for a 1960 Weil McClain hot water heating boiler (pictured below) that had a BTU input of 625,000. This boiler accident happened in February 2013.

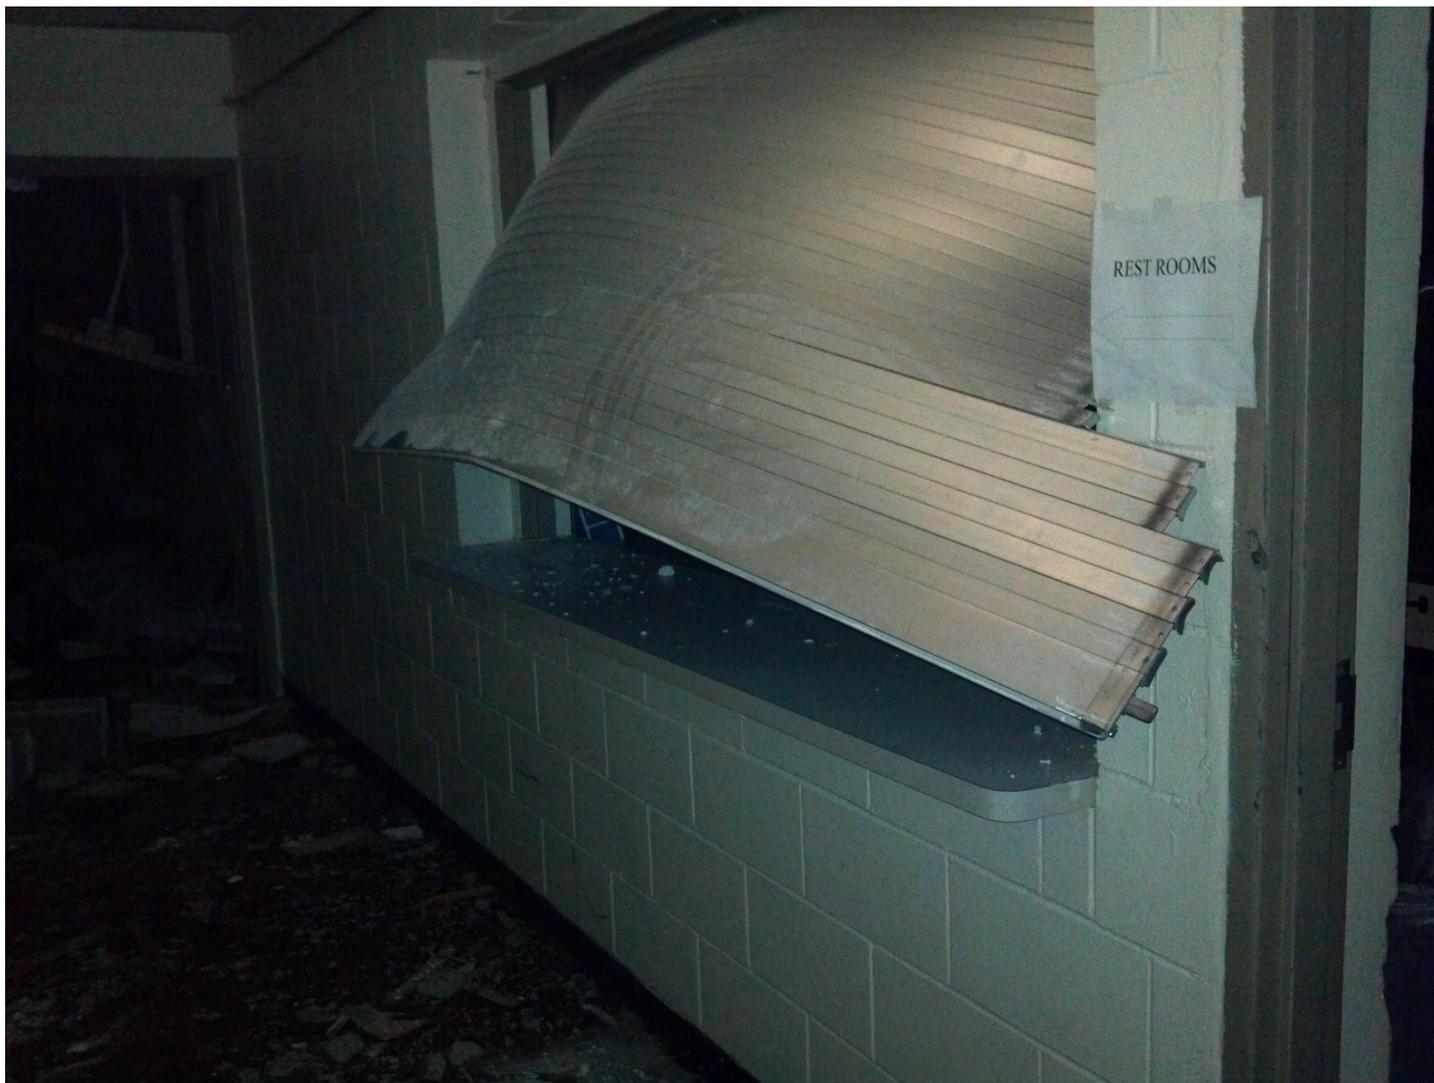
A photo of the damaged roll-up doors for the kitchen.

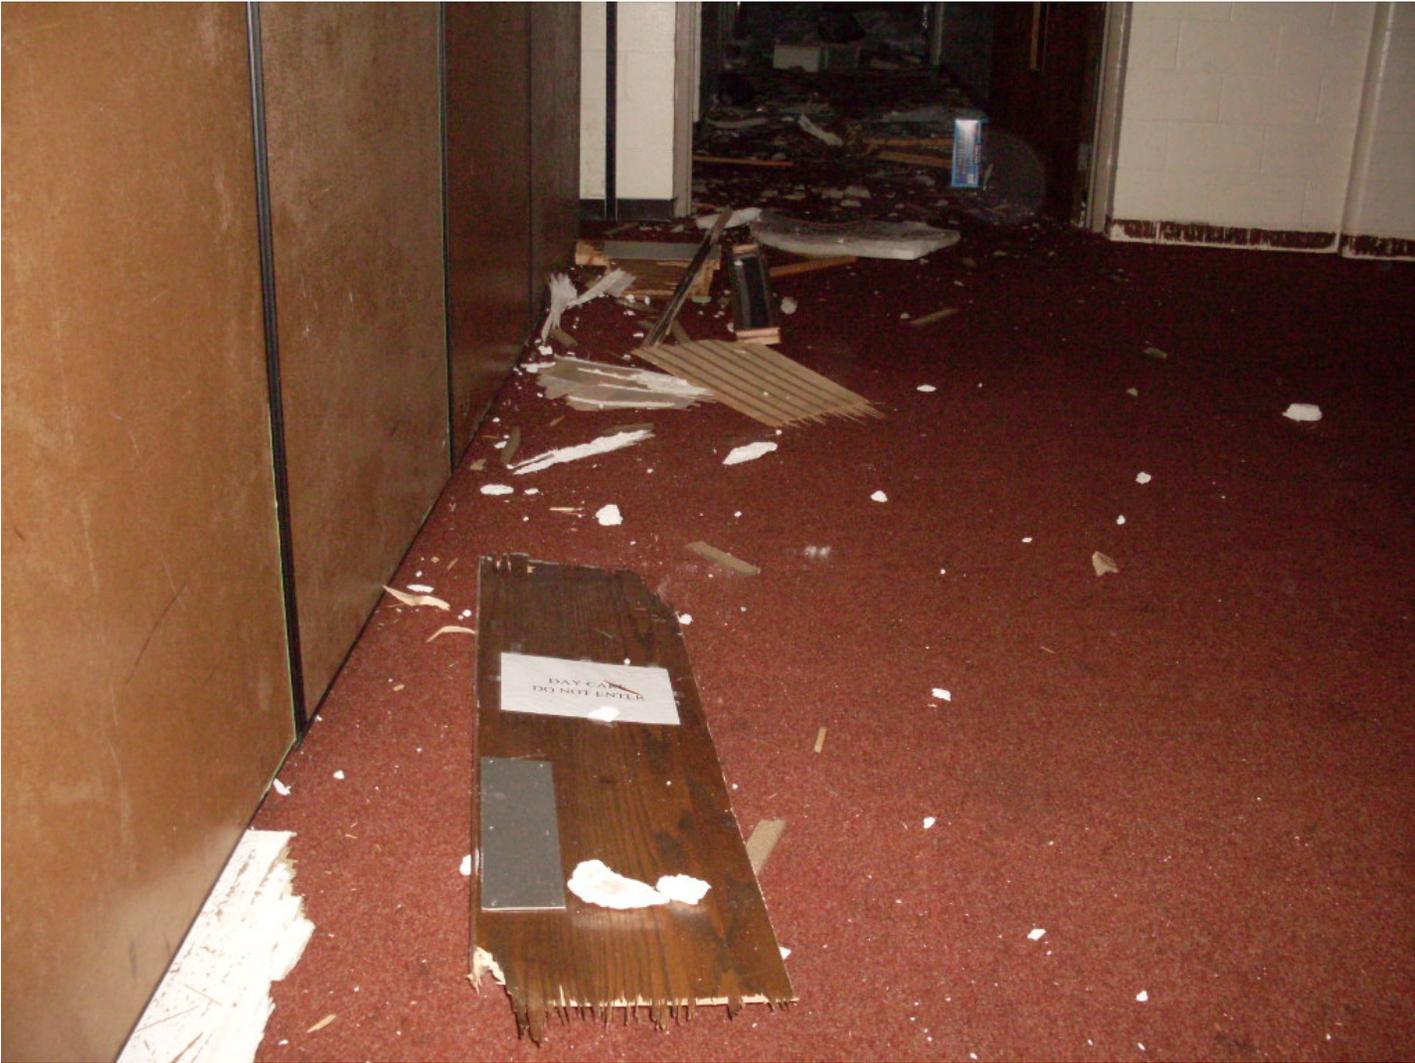
Here is one of the double doors from the north/south hallway. The door is now in the middle of the daycare sleeping room 50 feet from its original location.

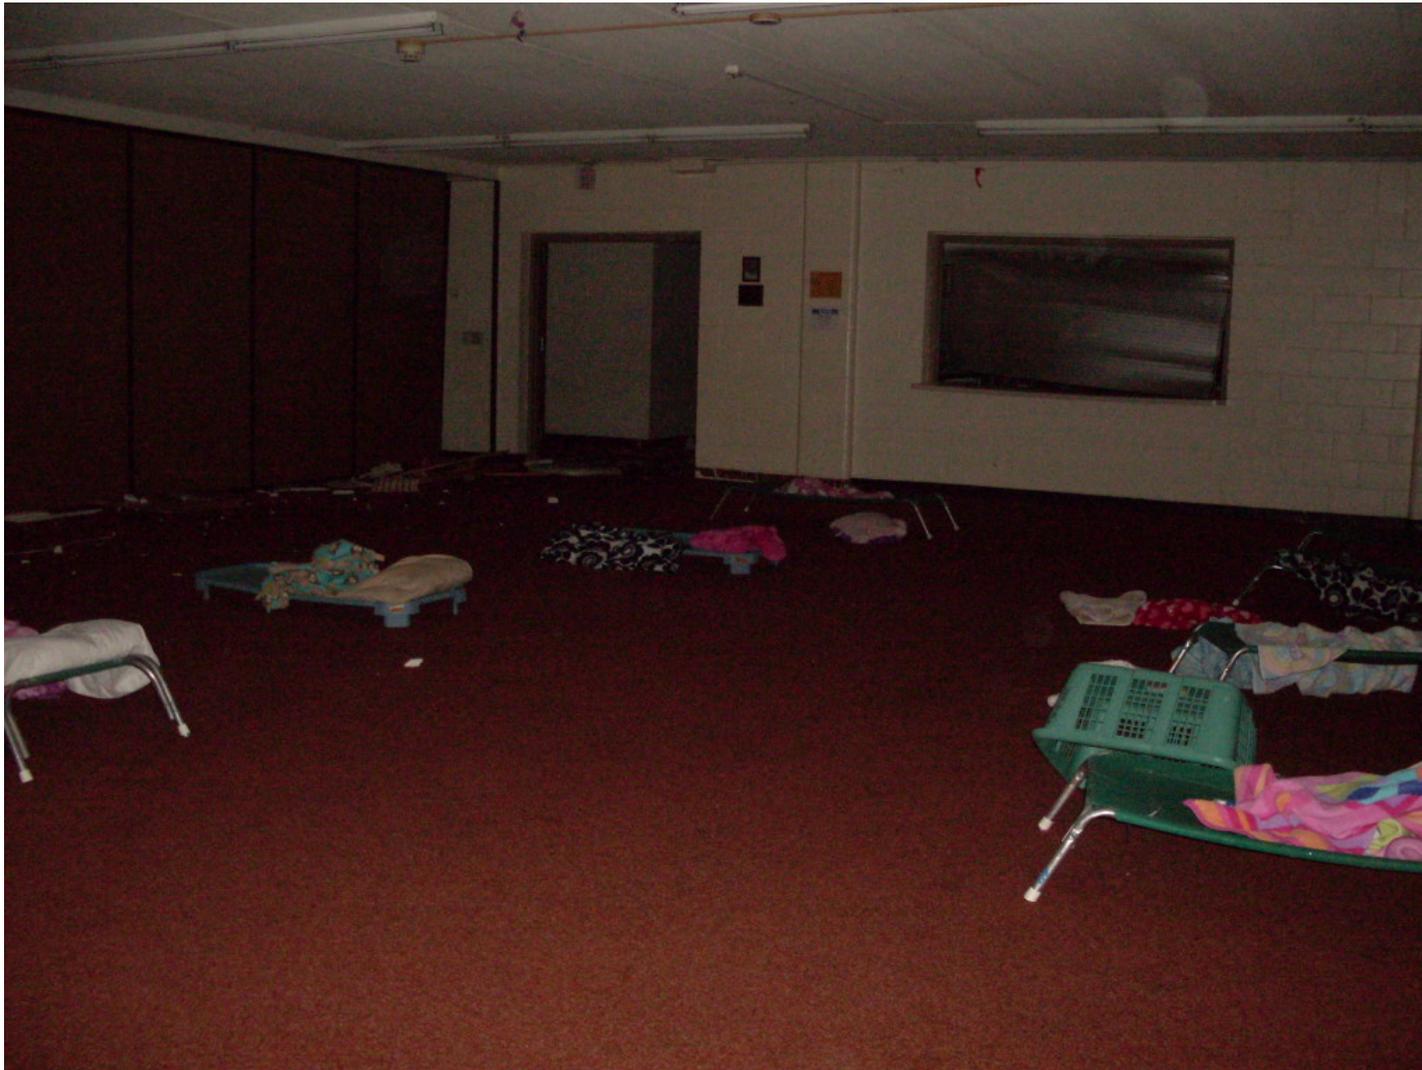
Here is of the daycare sleeping room. Notice the kitchen's damaged roll-up window cover and debris along the left side of the room.

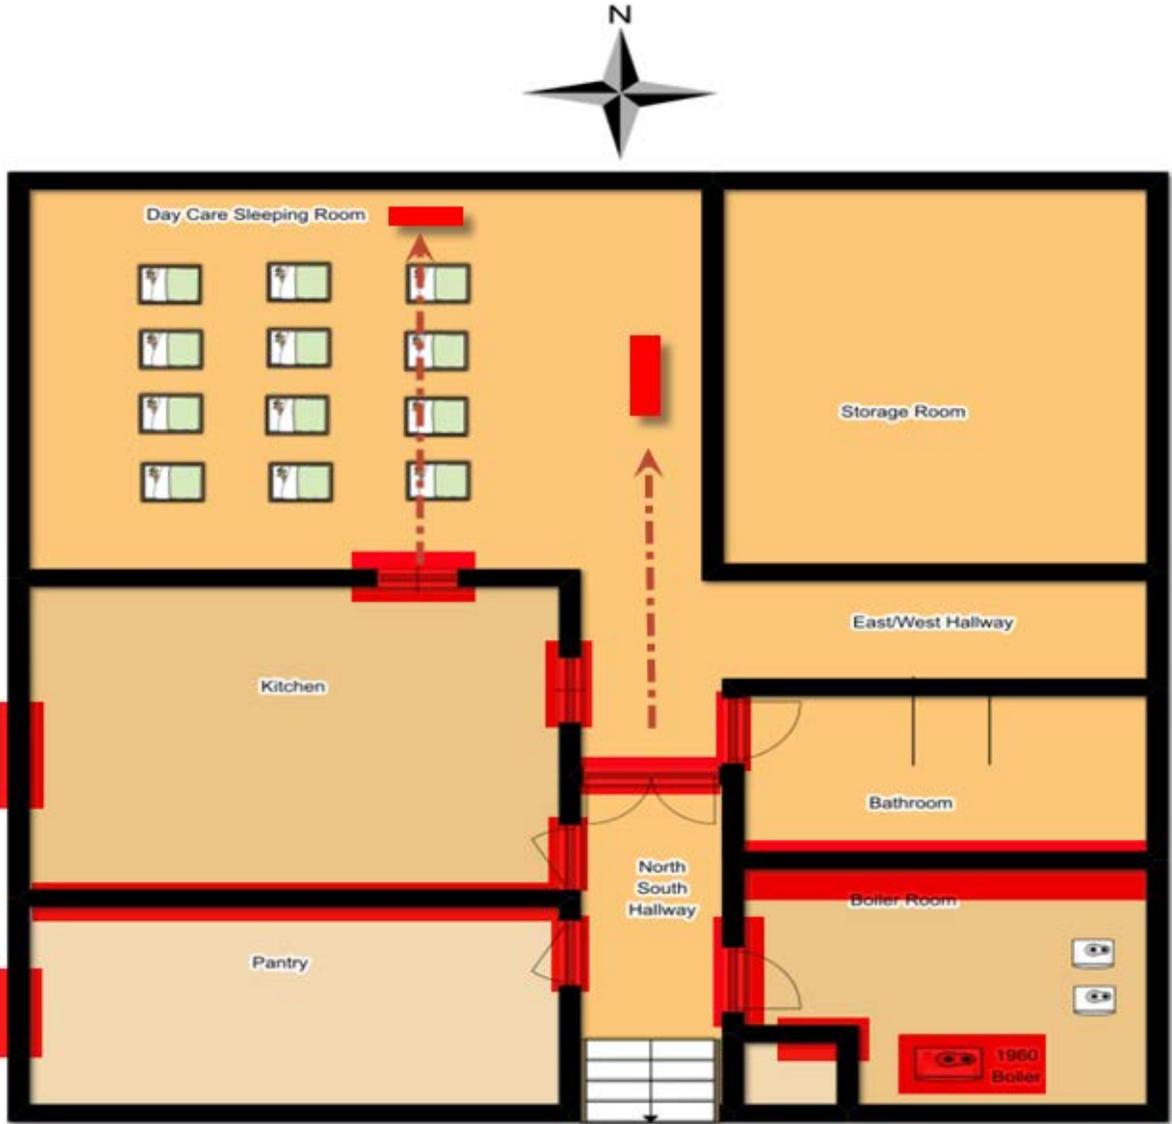
The highlighted walls were completely destroyed, including the first floor above the boiler room.
