## **A Technical Analysis:**

### **The Performance of Composite Wood Joists Under Realistic Fire Conditions**

*Melissa Avila,*  
*Project Engineer,*  
*New Technology Group*  
**Tyco Fire Suppression &  
Building Products**

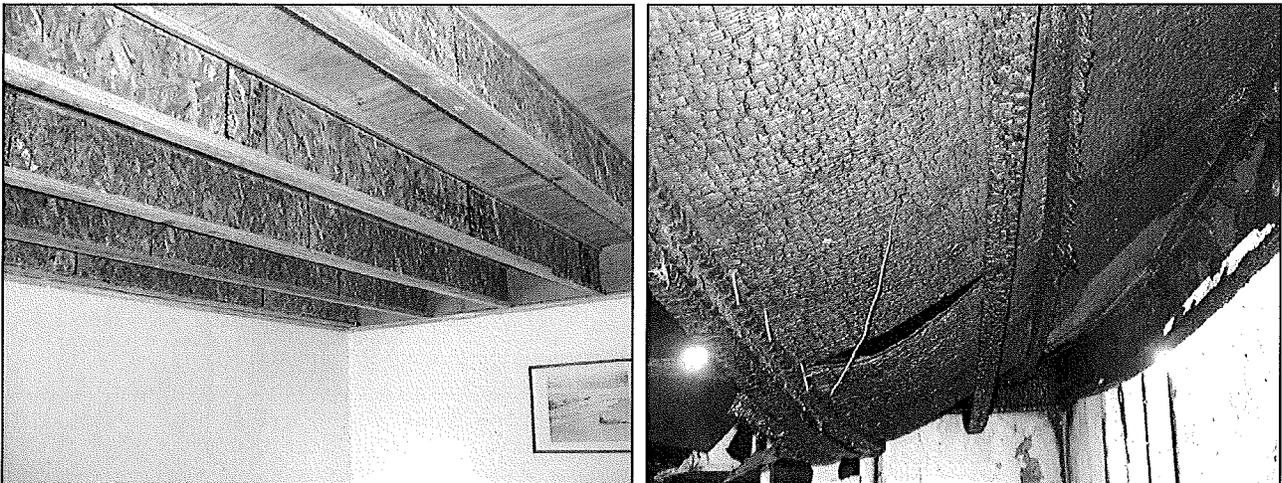
Figure 1: Composite wood joists before (left) and after fire exposure

Note how the composite wood joists exposed to a fire event have fallen apart due to the failure of the web, causing the ceiling to collapse. There is growing evidence that the materials employed in lightweight construction are more apt to weaken and fail much faster than conventional construction materials, resulting in sudden catastrophic collapse of ceiling and floor assemblies and an increased risk of injury or death to building occupants and firefighters.

One example of the difference in fire performance of a lightweight structural member compared to solid sawn lumber is the behavior of composite wood joists. When a composite wood joist is exposed to fire, the thin oriented strand board used as the web in the joist is quickly consumed, which results in an inability of the joist to carry load and ultimately a failure of the supported floor assembly. While a solid sawn joist behaves in much the same way, there is significantly more mass that must be consumed before the member reaches the critical point where it is no longer able to carry load. Due to the greater mass per unit of surface area of the solid wood joist, it will support the floor assembly for much longer than its lightweight alternative when exposed to equivalent fire conditions. Figure 1 demonstrates a typical composite wood joist before and after fire exposure.

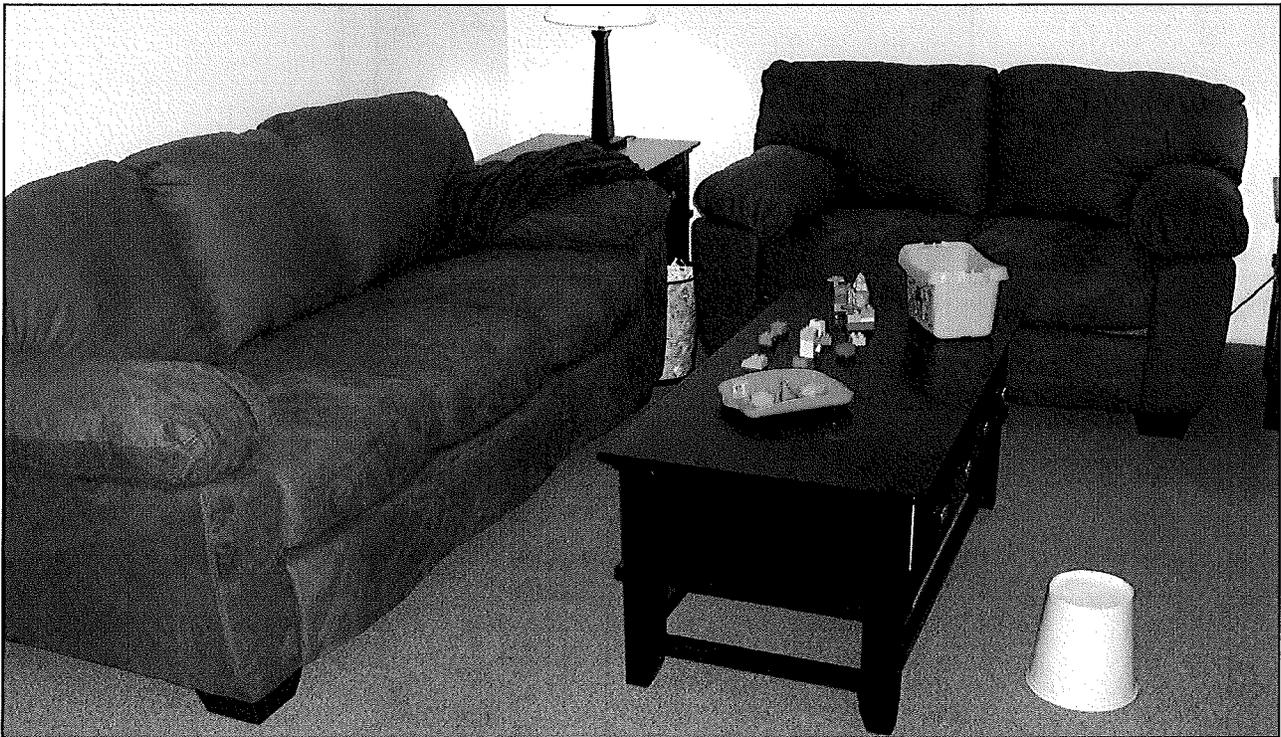
Figure 2: Fuel package used for all tests. White bucket on floor was used to protect floor radiometer during setup; the bucket was removed prior to each test.

Many of the firefighting deaths associated with lightweight construction occur as a result of a fire initiating in the basement area of a home. This scenario is particularly hazardous because firefighters frequently enter on the main level of the house, unaware of the exact location of the fire. Additionally, this is the one area of the structure where it is common to find likely sources of ignition including workshops, impromptu living areas and fuel fired equipment such as boilers and hot water heaters. Finally, in most cases the framing material is exposed, allowing fires to rapidly involve the structural members supporting flooring on the main level of the house. To simulate this scenario, the test setup represented a seating area that has been located in a basement. This scenario was selected since the large volume of synthetic material (i.e. furniture, carpet, etc.) is particularly challenging to the sprinkler system. However, any scenario that would lead to involvement of the structure and ultimately flashover of the compartment most likely would have generated equivalent results to this fuel package. The fuel package arrangement utilized is demonstrated in figure 2.

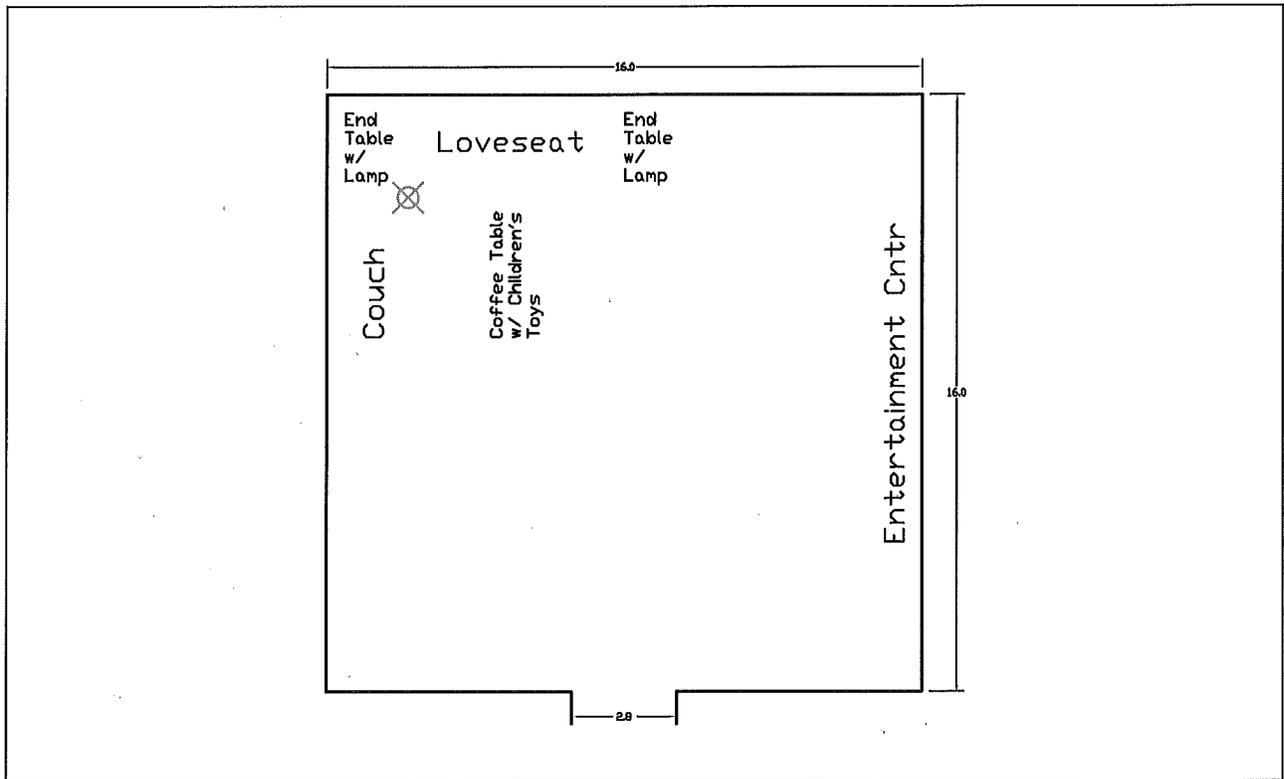
Figure 3: Test setup in plan view. The red symbol represents the ignition location.

The seating area measured 16 ft. x 16 ft. in plan area with a ceiling height of 8 ft. to 9 ft. 2 in depending upon the floor assembly tested. A single doorway measuring 34 in. in width and 80 in. in height was centered on the wall opposite the ignition corner. The walls were constructed of trade size 2 in. x 4 in. studs covered with two layers of a nominal ½ in. sheet rock painted with a standard commercial latex paint. Figures 3 and 4 show the dimensions of the test compartment and the placement of items in the room. The total fuel package, excluding the combustible components of the structure, included a couch and loveseat, a coffee table with plastic children's toys, two end tables with lamps, a picture on the wall and an empty entertainment center. The floor was covered in a standard Berber type carpet. The ignition scenario included a small wastebasket filled with a ½ lb of shredded 20 lb copy paper and a polyester blanket draped over the arm of the couch.

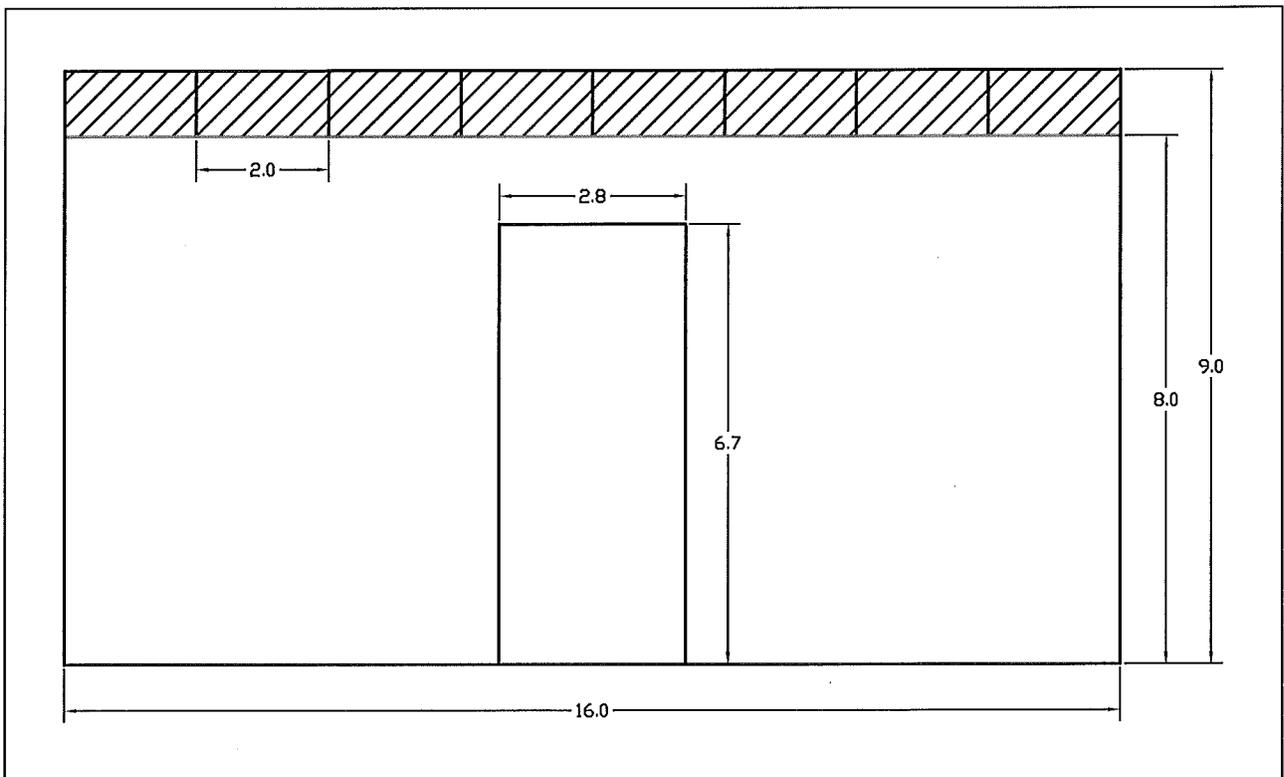
Figure 4: Test setup in elevation view. The horizontal red line represents the sheetrock on the ceiling (in exposed tests) or the bottom of the joists (in unexposed tests).

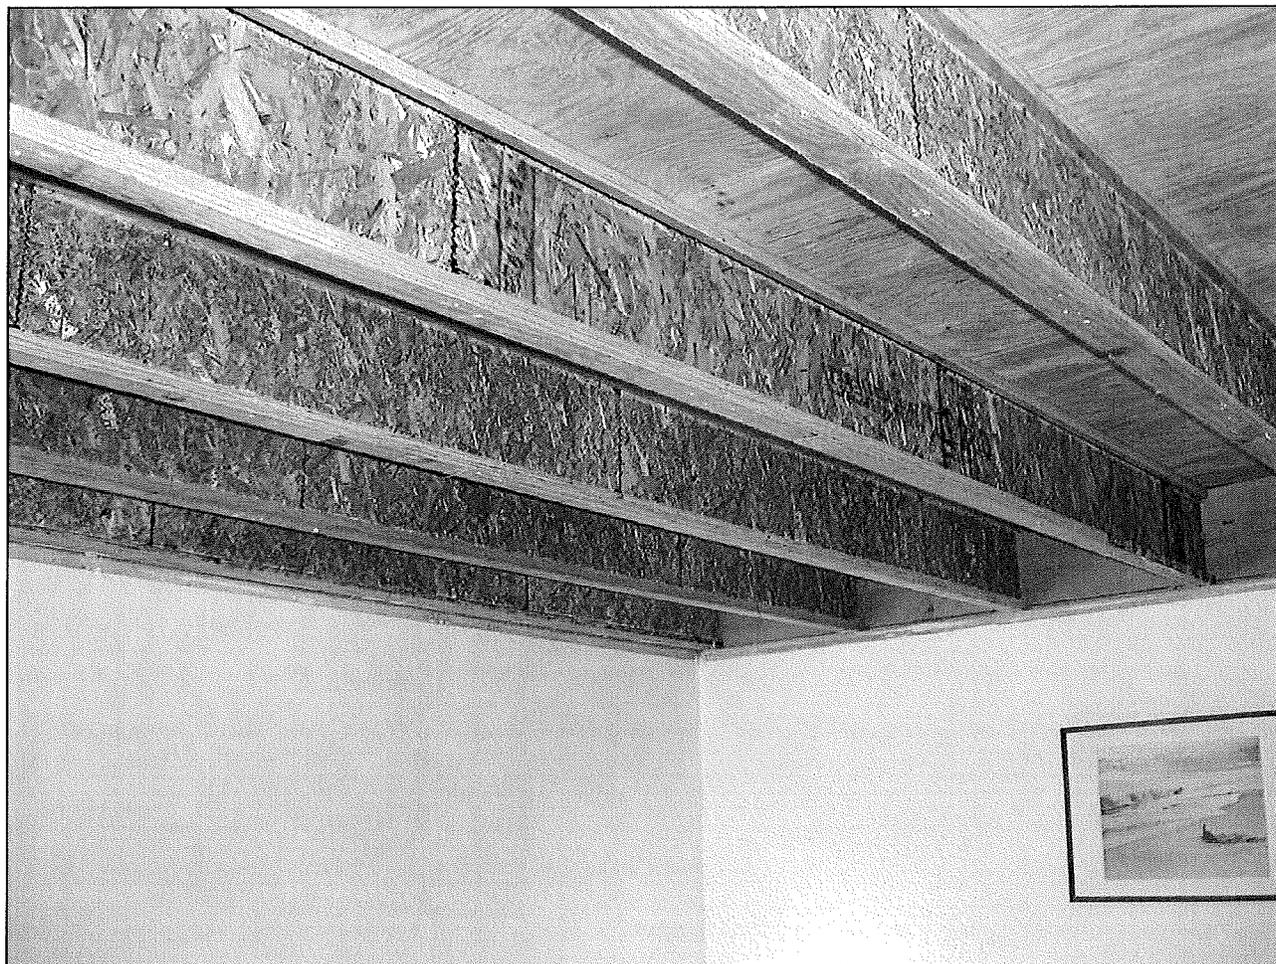
Figure 5: Exposed composite wood joists representing main level floor assembly

The ceiling was constructed of composite wood I-joists measuring 11-7/8 in. deep with 3 in. wide chords. The joists were spaced two feet on center (i.e. the typical maximum spacing for residential occupancies) and the bottom of the beams was eight feet above the floor. In one of the tests (Test 1), the bottom of the joists was also covered with two layers of 1/2 in. sheetrock; all remaining tests were conducted with the joists exposed as shown in figure 5.

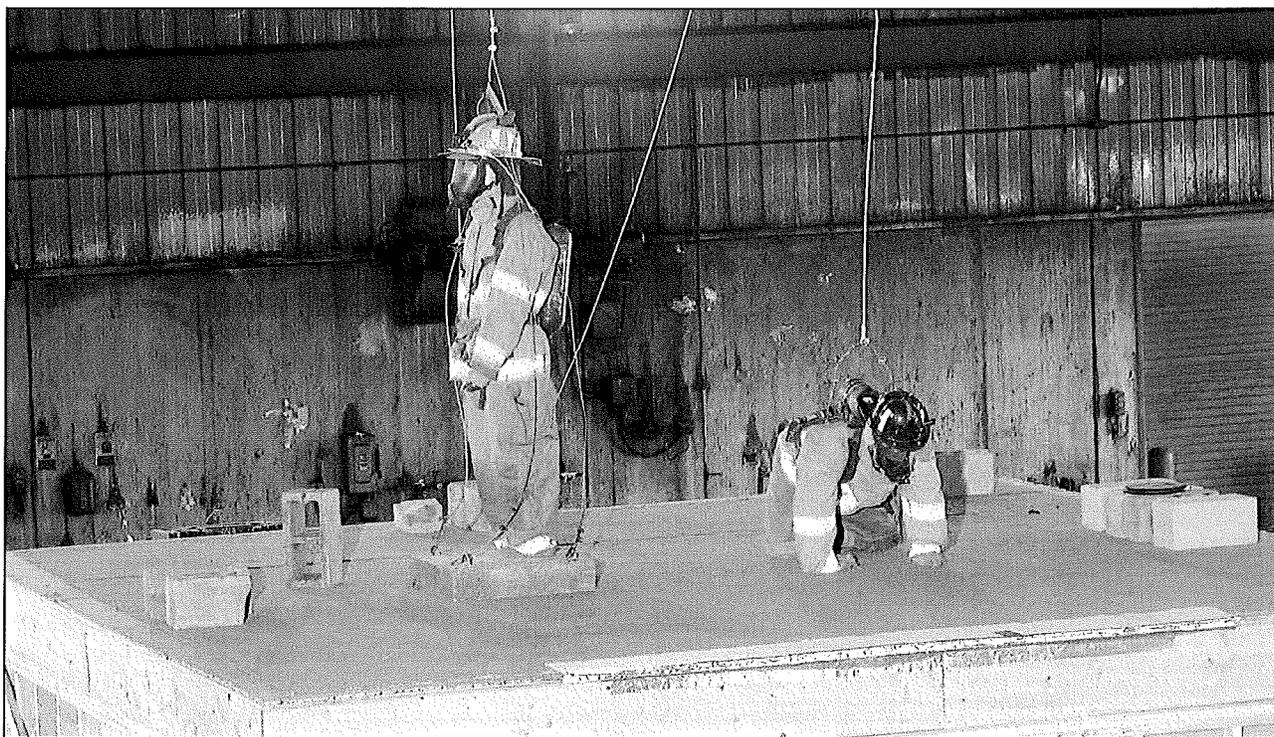
Figure 6: Loading on top of enclosure

To represent the main floor above the simulated basement, the composite wood joists were sheathed in 7/8 in. plywood subflooring. To accurately capture the heat transfer through the assembly, the floor was finished with a typical residential carpet pad and Berber carpeting. Concrete blocks were used in an effort to simulate a typical live load representing the furnishings above the test enclosure. These blocks were weighed and located to represent the same arrangement as the furniture package in the basement area below. Additionally, two fire fighter mannequins were positioned on top of the ceiling/floor assembly as shown in figure 6. The firefighter mannequins were outfitted with typical items including turnout gear, a helmet and a self contained breathing apparatus (SCBA). The standing mannequin, standing on a joist, weighed 300 pounds while the crawling mannequin, straddling a joist, weighed 380 pounds. The remainder of the cinder blocks totaled 600 pounds resulting in a total live load of 1280 lbs or about 5 lbs/ft<sup>2</sup>. The firefighters were attached to the ceiling with cables to permit them to be pulled from the burning compartment after the collapse of the ceiling/floor assembly.

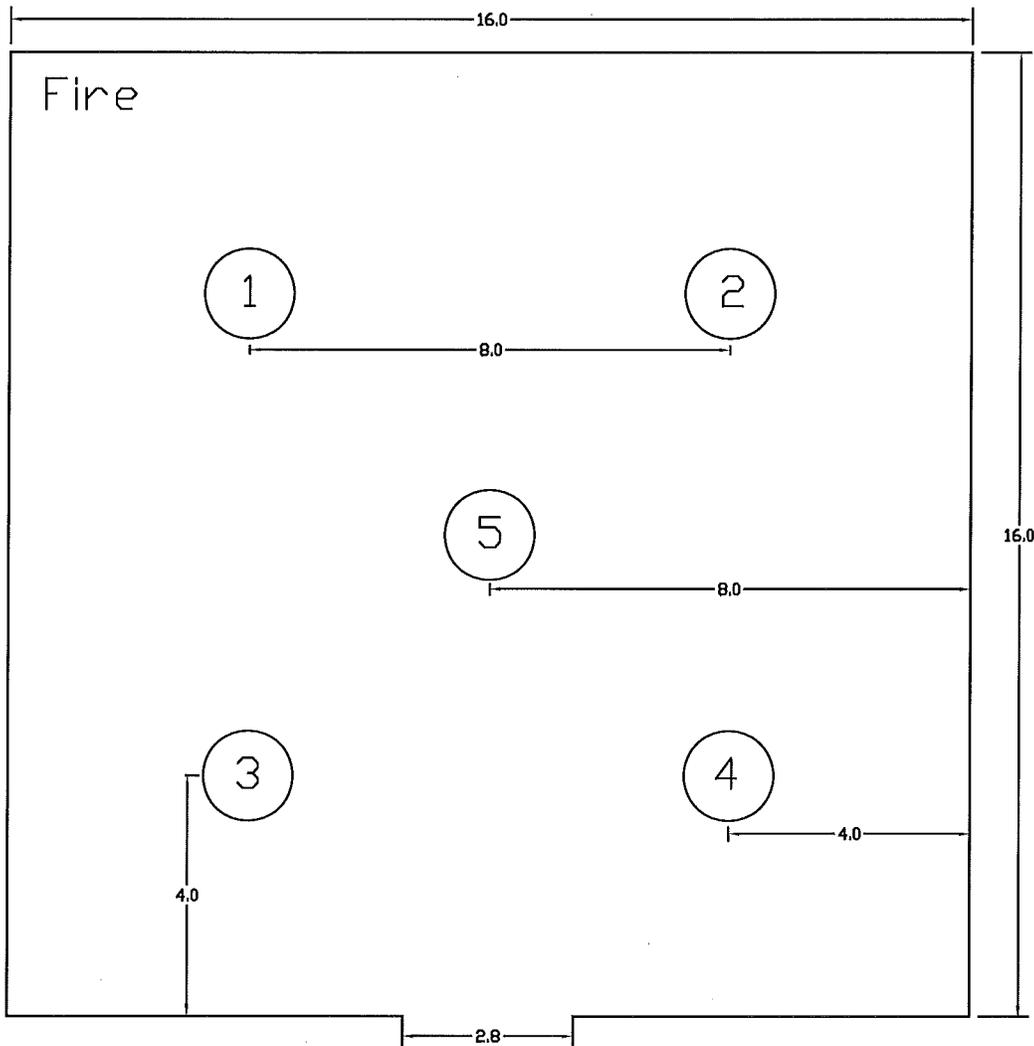
Figure 7: Additional thermocouple locations. Each location contained 20 thermocouples except for location 4, which had only 8 thermocouples.

In Test 5, additional instrumentation was added in an effort to better understand the method of collapse as well as to verify temperature readings from the thermal imaging camera from previous tests. Twenty thermocouples were added at five different locations for a total of 88 additional thermocouples with respect to the previous tests (the location farthest from the fire had only eight thermocouples due to restrictions from the data acquisition system). Thermocouples were located in the ceiling/floor assembly starting at the carpet on top of the structure all the way down to the plywood sheathing. Temperature measurements were also taken on each side of the joist and embedded into the joist at each location. The location of each thermocouple group and the arrangement of the thermocouples at each location is shown in figures 7 and 8, respectively.

For the second unsprinklered test, additional instrumentation including 88 more thermocouples (see figures 7 and 8 for location) was included to better understand the progression of the fire through the structure. The additional thermocouples were located in and around the joist as well as in the ceiling/floor assembly layers to understand the heat transfer through and failure mechanism of the ceiling/floor assembly. A Scott Health and Safety Eagle Imager® 160 Thermal Imaging Camera, a type commonly used by firefighters in structure fires, was used to measure the carpet temperature on the floor above. The readings from the thermal imaging camera are one source of information for an incoming firefighter that may provide some warning of impending collapse.

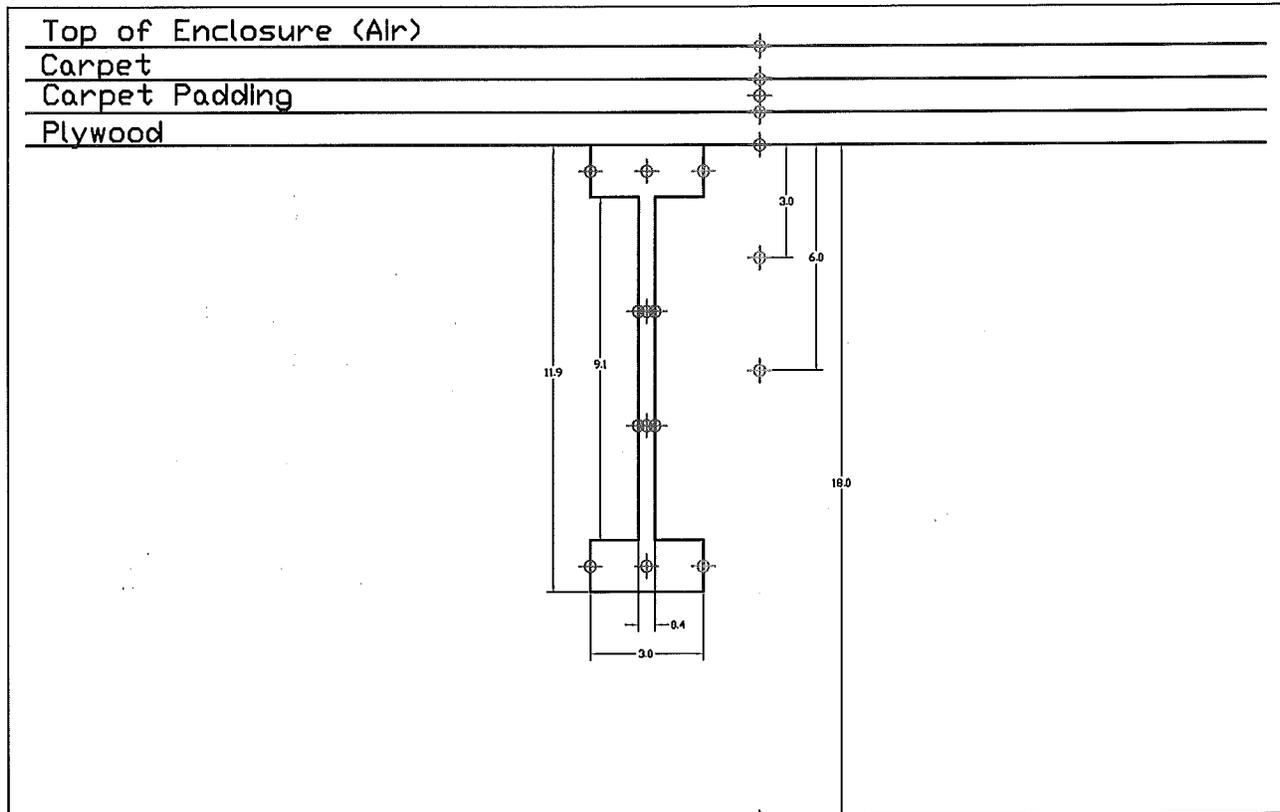
Figure 8: The thermocouple arrangement at each location. The green symbols represent thermocouples that were present at all 5 locations; the blue symbols represent the thermocouples that were at each location except location 4.

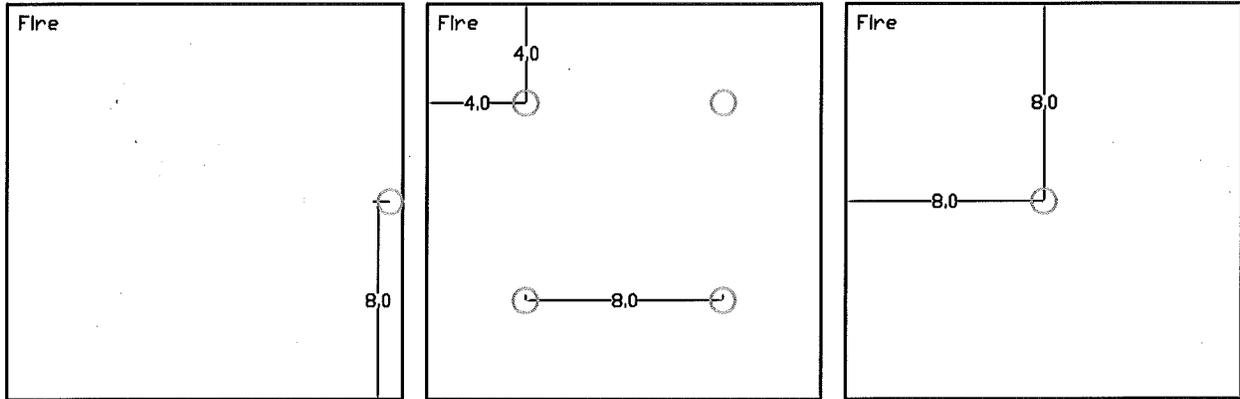
Figure 9: Sprinkler layouts for Test 1, Test 2 and Test 3 (from left to right)

Three sprinkler scenarios were evaluated as part of this program; including a single sidewall sprinkler, four pendent sprinklers and a single pendent sprinkler. Each scenario is demonstrated in figure 9 and the tests are described as follows.

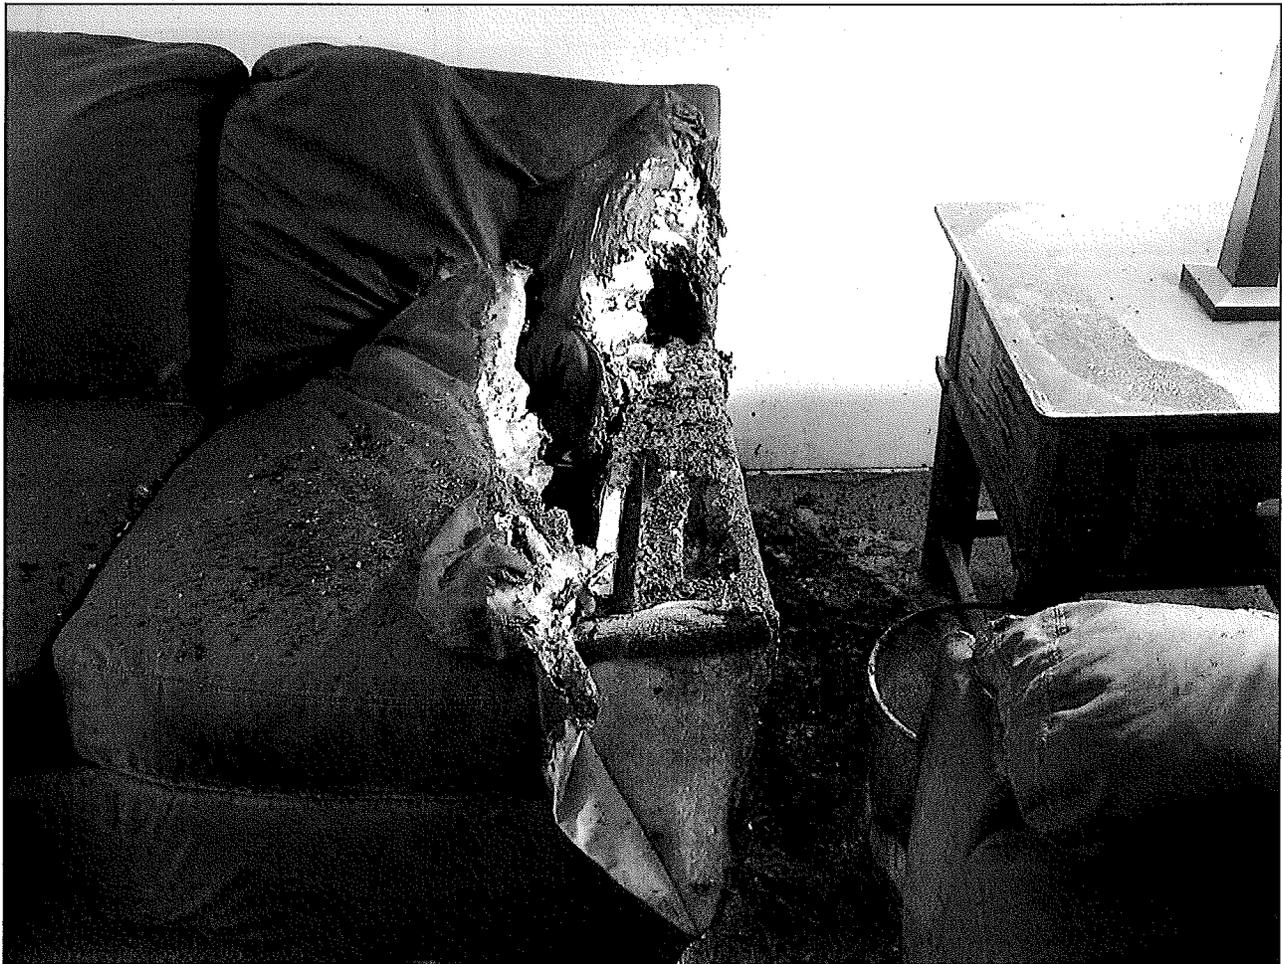
Figure 10: Test 1 Damage Assessment

In this test, the sprinkler operated 2:55 (min:sec) after ignition and control of the fire was achieved less than 2 minutes later. The damage, shown in figure 10, was limited to the items intimate with ignition.

The first test was considered successful due to the limited damage to the fuel package and the comparatively low temperatures that were maintained for the duration of the test. At no point during the test did the fire progress from the furniture into the structural portion of the test assembly.

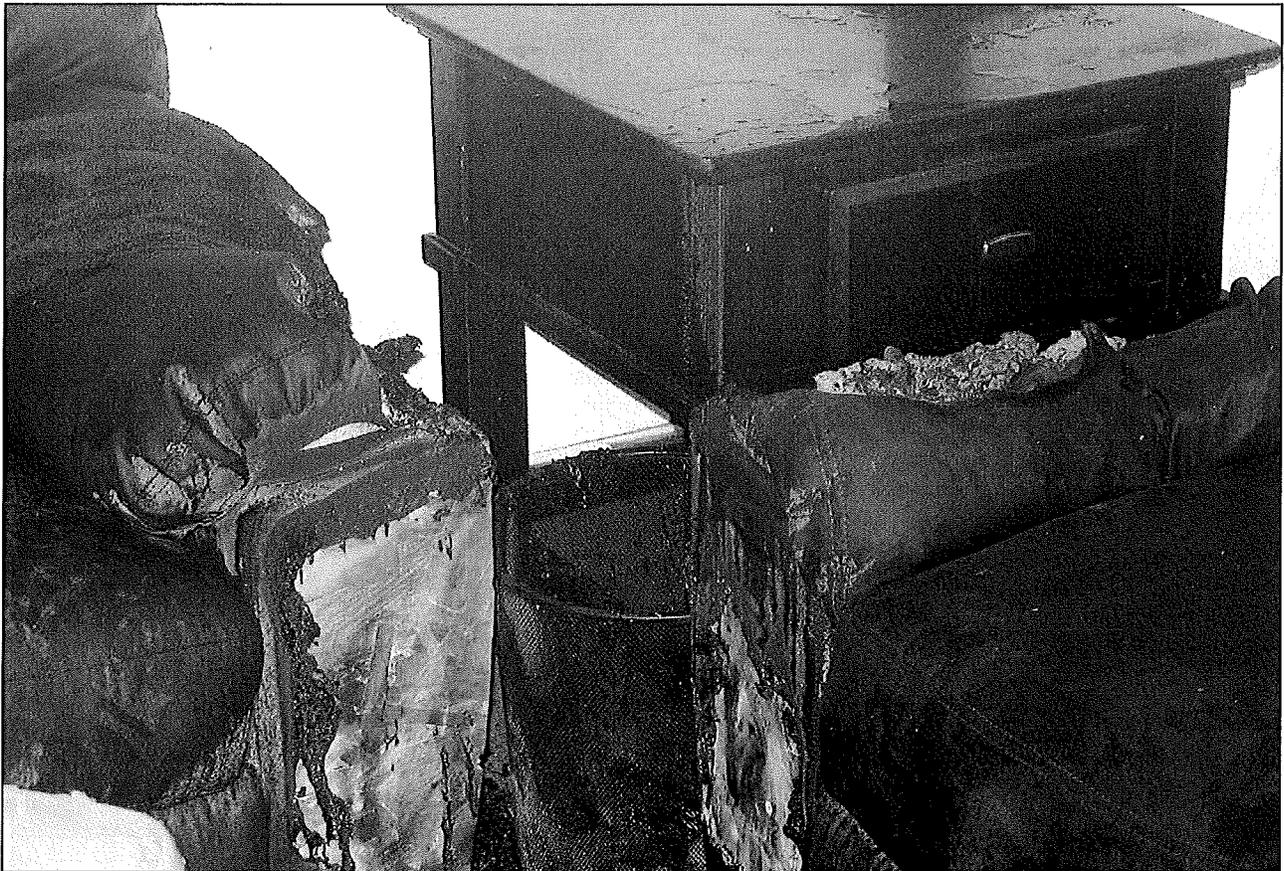
Figure 11: Test 2 Damage Assessment

Although there were four sprinklers in the room, a single sprinkler operated 1:13 from ignition and successfully controlled the fire within 3 minutes. The damage from the second test is demonstrated in figure 11.

The second test was considered a success due to the quick activation of the sprinkler limiting the damage to a small area of the room.

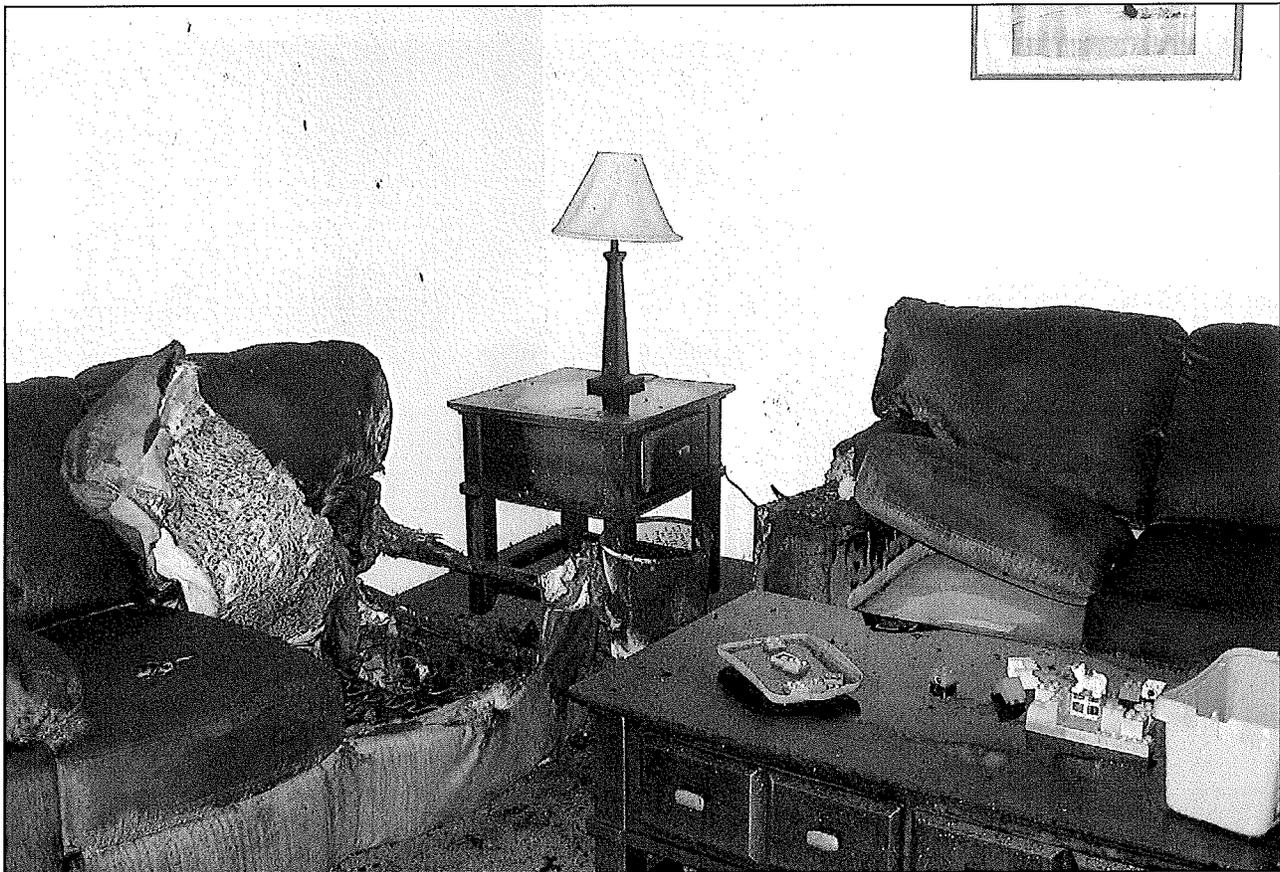
Figure 12: Test 3 Damage Assessment

The center sprinkler operated 3:19 from ignition and achieved control less than one minute later. The post-test damage is shown in figure 12.

This test was considered successful due to the relatively minor damage to the fuel package. At no point did the fire progress from the furniture to involve the structural elements of the test enclosure.

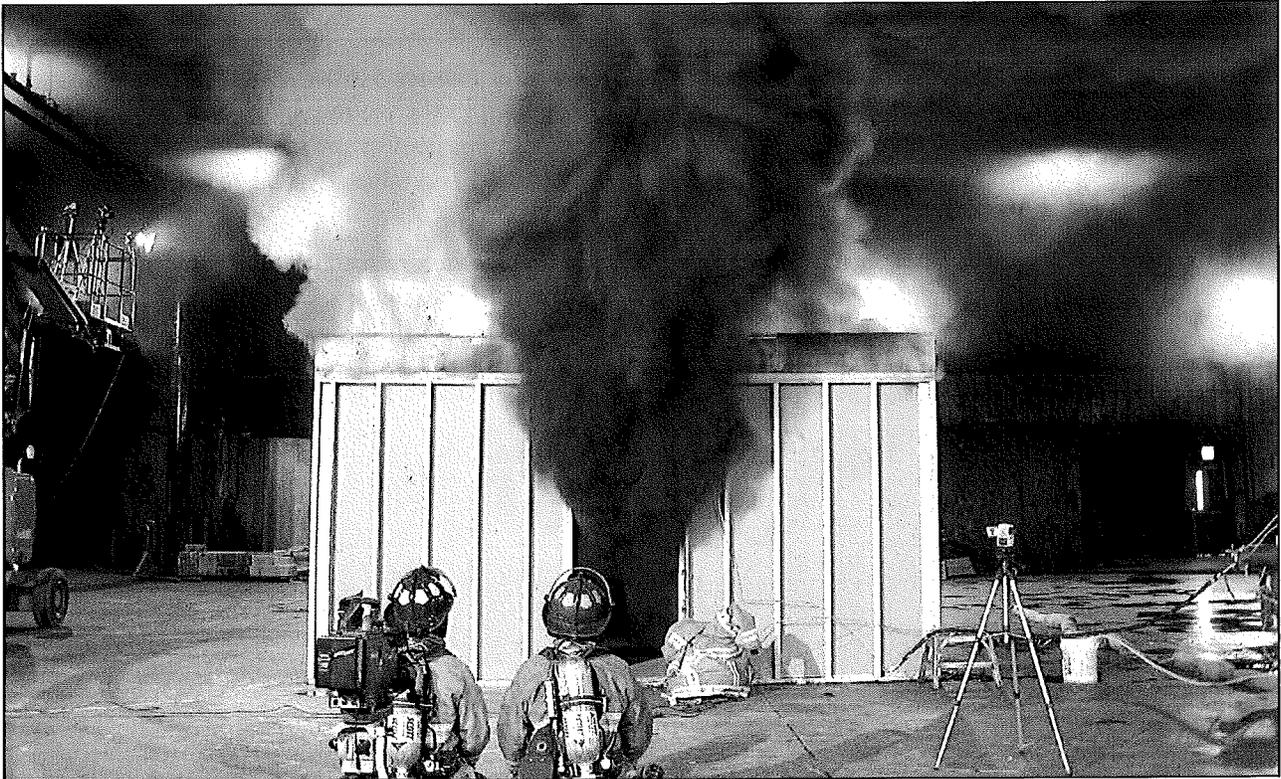
Figure 13: Test 4, first unsprinklered test, just before flashover

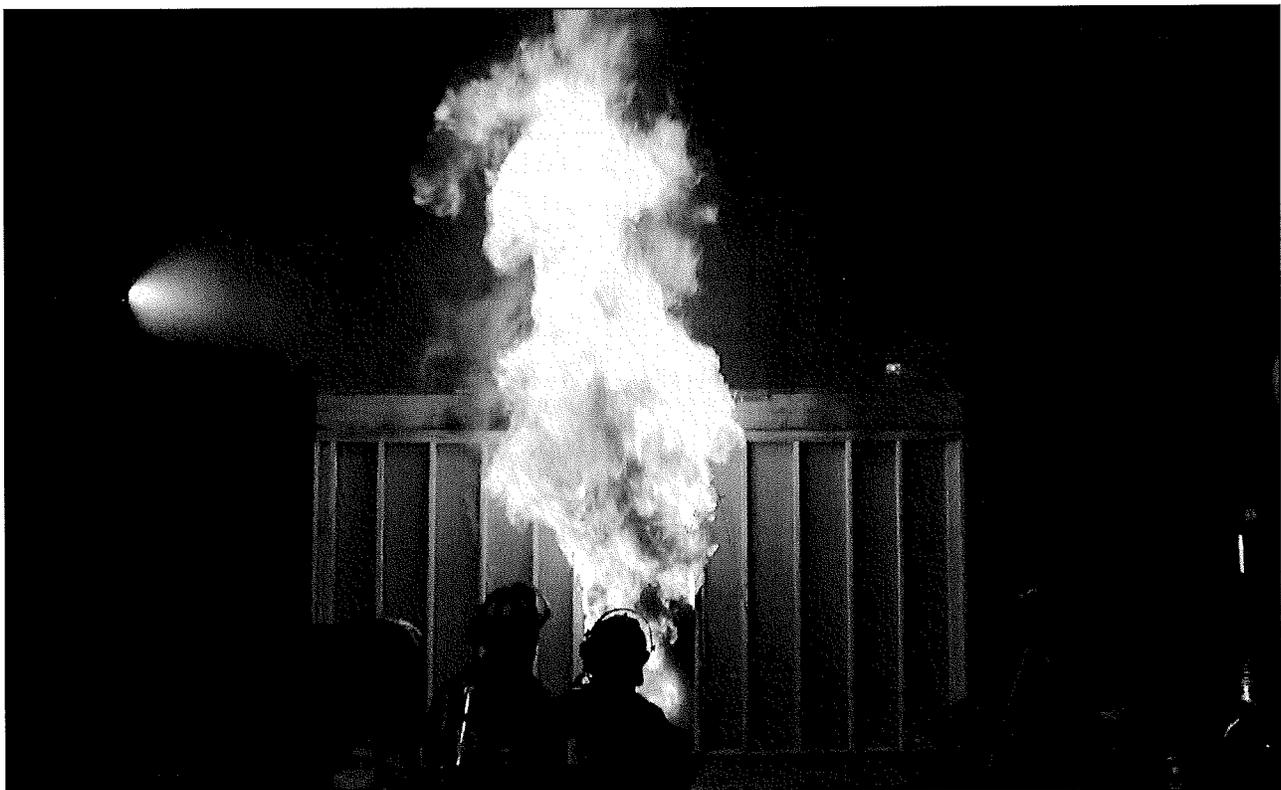
Figure 14: Test 4, first unsprinklered test, just after flashover

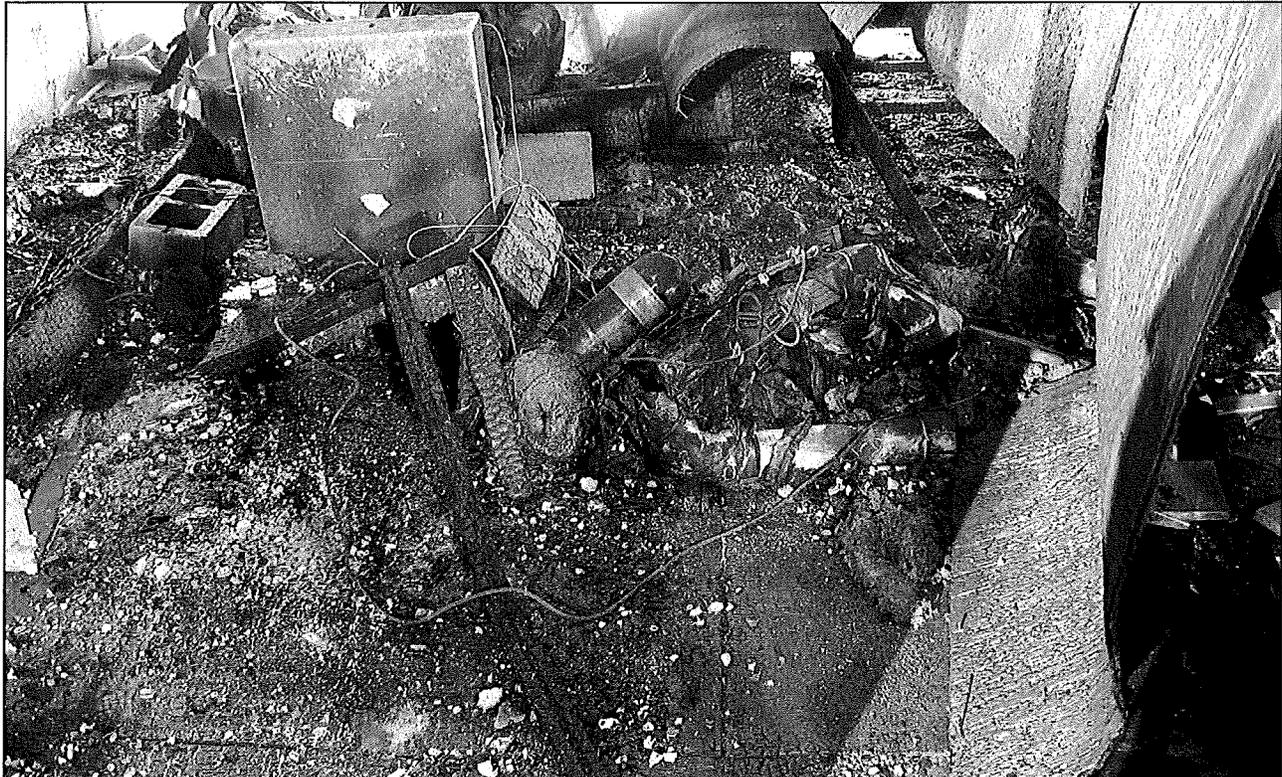
Figure 15: Test 4, first unsprinklered test, damage

Items that were on the floor above the fire room, including the cinder blocks and the firefighter mannequins, fell into the fire room and were severely damaged. The plywood subflooring that was above the joists on the ceiling fell in and can be seen on the right side of figure 15.

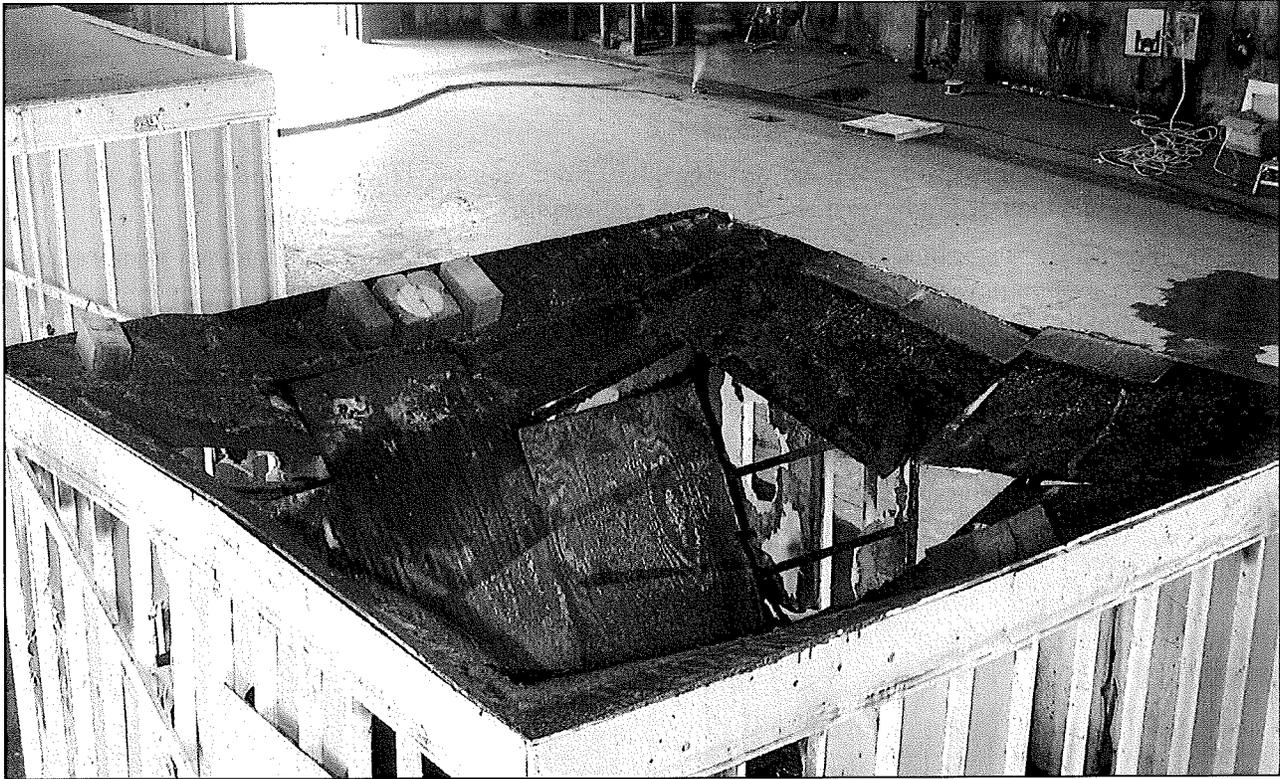
Figure 16: Test 4, first unsprinklered test, roof collapse of structure

The damage to the ceiling and the joists is shown in figures 16 and 17.

Almost the entire 16 ft. x 16 ft. ceiling collapsed into the test compartment in a near simultaneous event. The web in most of the composite wood joists was completely consumed by the fire prior to collapse. One of the engineered I-joists that retained a portion of its web is shown in figure 17. The web was almost entirely consumed in the middle and the joist itself was no longer capable of supporting a load, leading to collapse. Some examples of engineered I-joists with only the chords left can be seen under the collapsed plywood in figure 16.

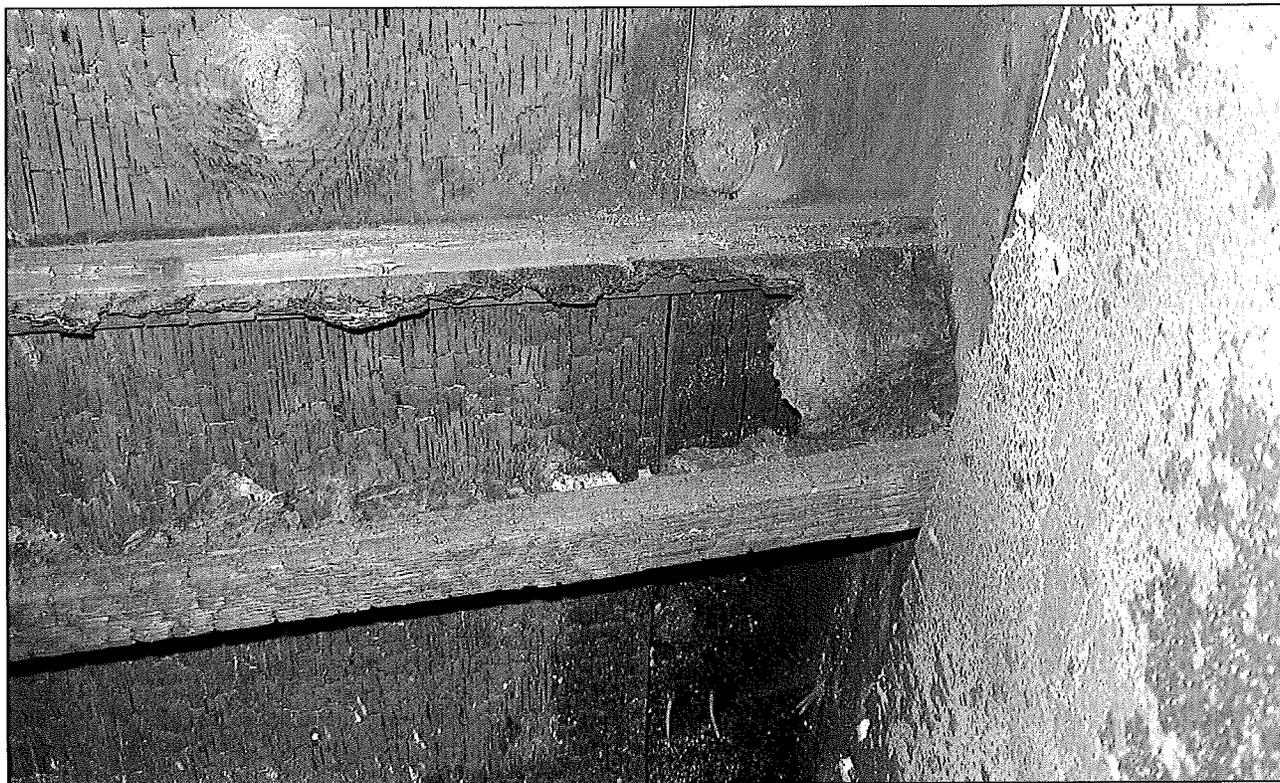
Figure 17: Test 4, first unsprinklered test, one of the few remaining engineered joists on the ceiling. Note how the webbing is almost entirely consumed.

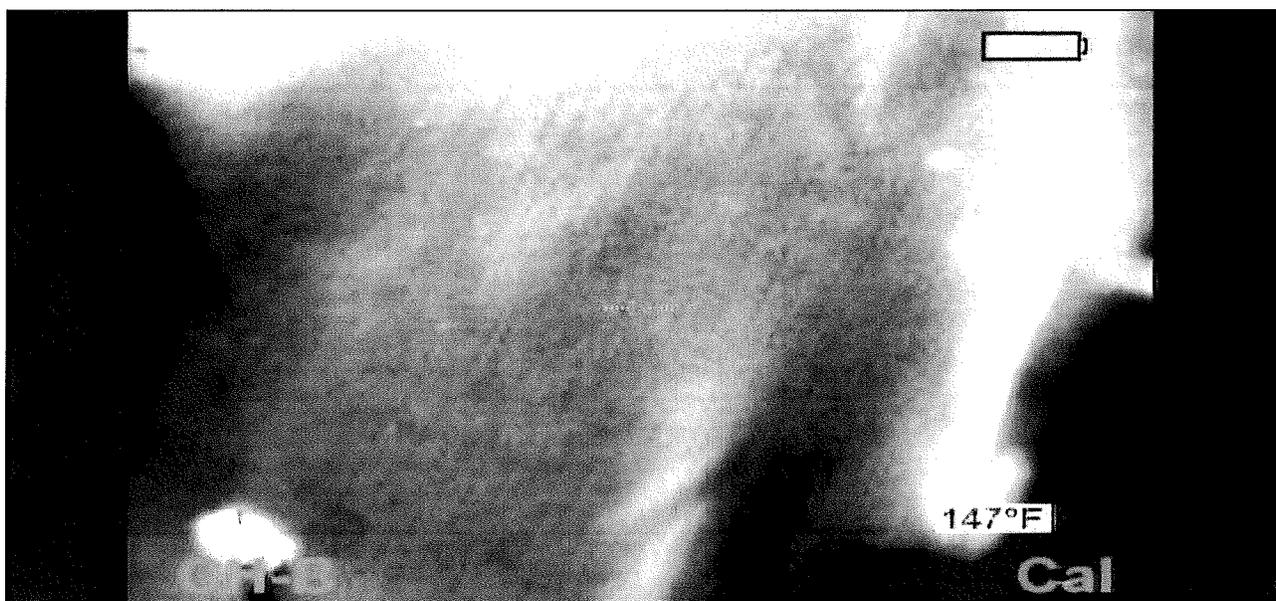
Figure 18: Test 5, second freeburn test, snapshot from the thermal imaging camera shortly before collapse of the structure

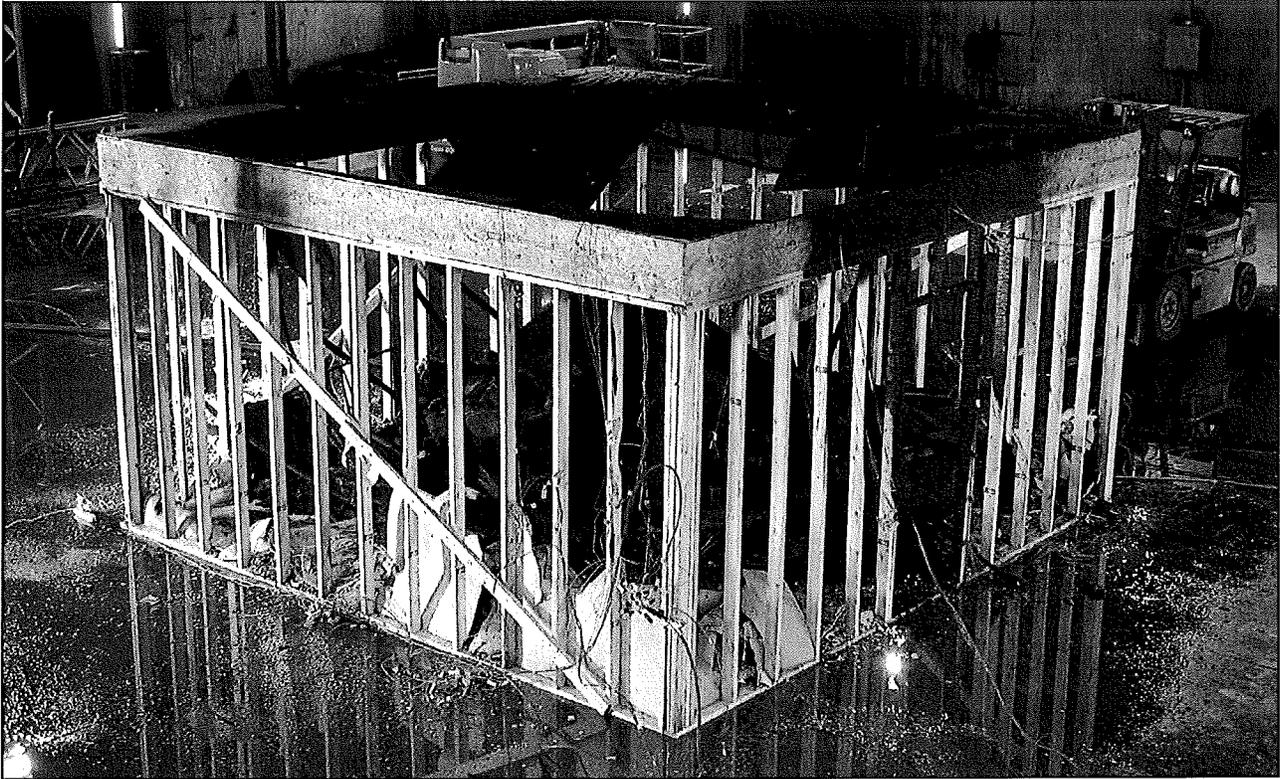
Figure 19: Test 5, second freeburn, damage

The fire damage was more extensive in the second freeburn as compared to the first as demonstrated in figure 19. The fire was so intense that although the mannequins were rapidly retrieved after falling through the simulated floor assembly, the turnout gear was destroyed and the underlying plastic forming the mannequin melted. The Scott Health and Safety thermal imaging camera that the standing mannequin was holding also did not transmit sensible data for more than 30 seconds after collapse and was destroyed.

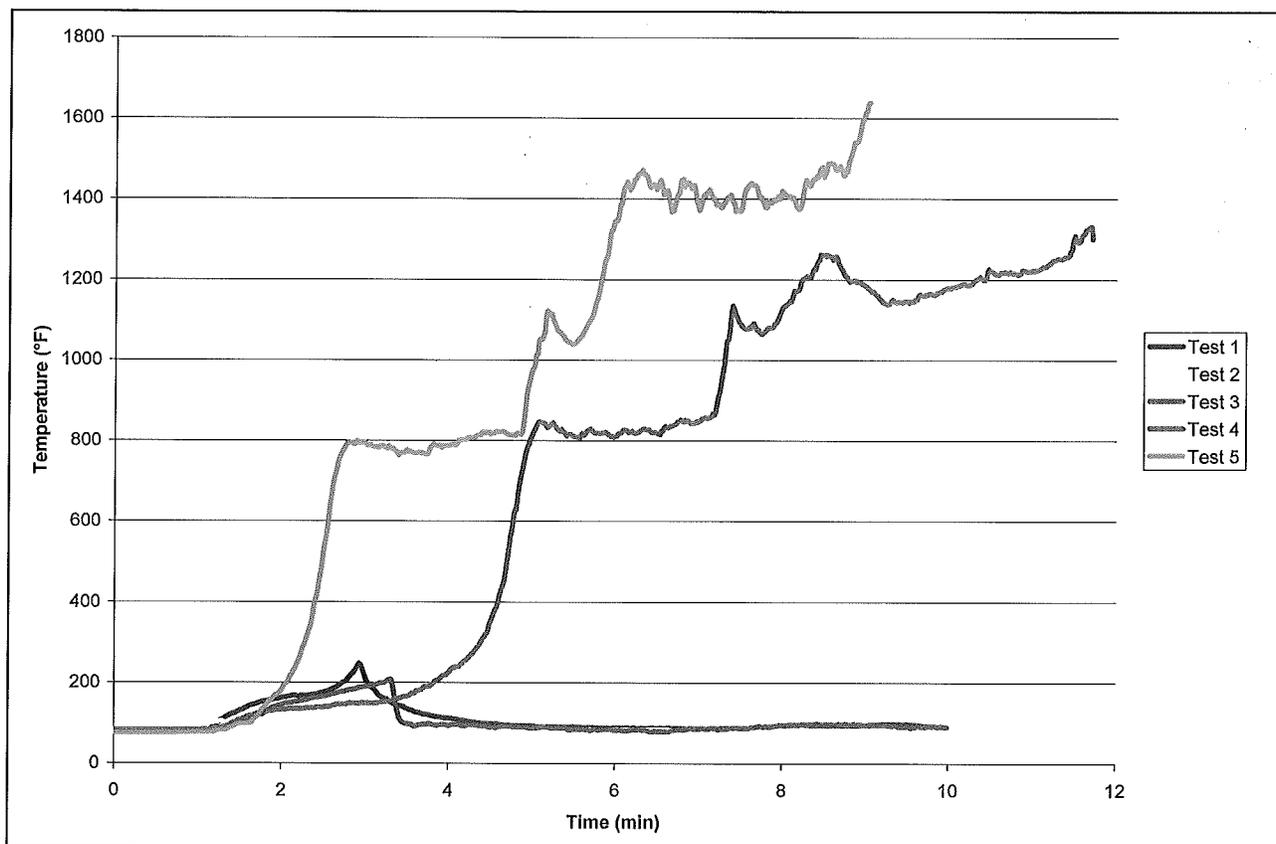
Figure 20: Comparison of temperatures 1 ft. below the top of the doorway

Temperature measurements were taken at 1 ft. intervals in the doorway. The thermocouples near the top of the doorway will record the highest temperatures since they are located in the smoke and, in the case of flashover, fire that exits the room. Figure 20 shows the highest temperatures out the exit as measured by the thermocouple located approximately 1 ft. below the top of the doorway.
