## **A Technical Analysis:**

### **The Performance of Composite Wood Joists Under Realistic Fire Conditions**

*Melissa Avila,*  
*Project Engineer,*  
*New Technology Group*  
**Tyco Fire Suppression &  
Building Products**

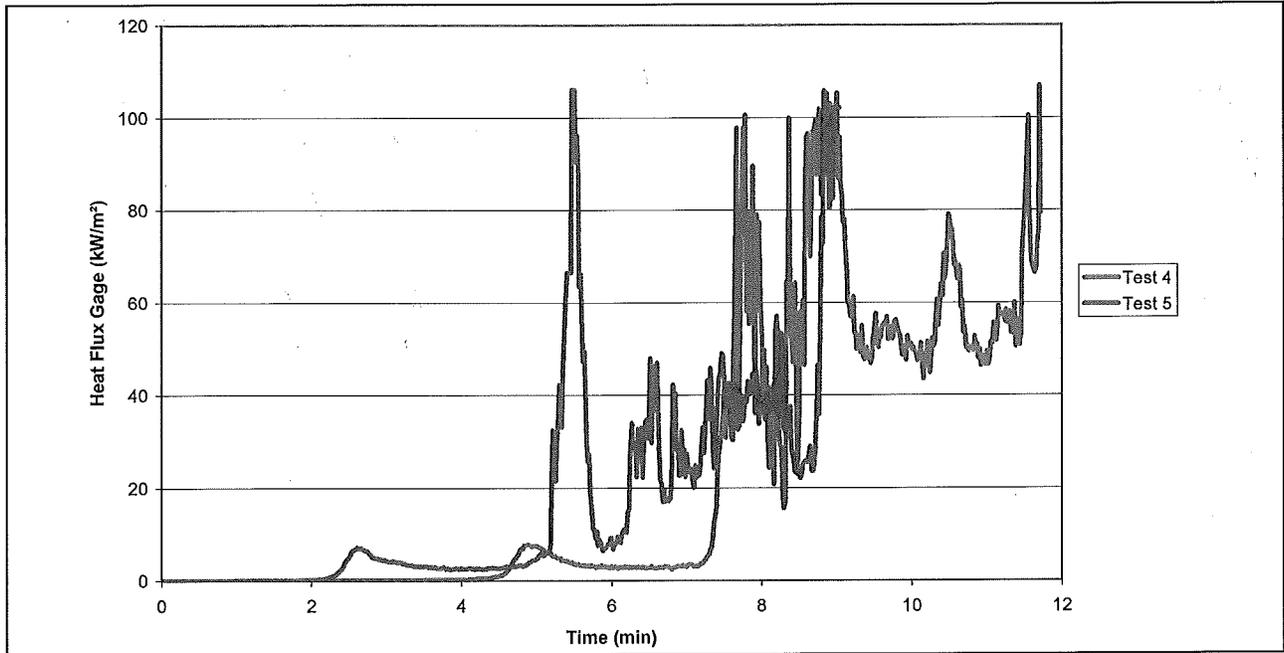
Figure 21: Reading from radiometer located on floor for both unsprinklered tests

One of the criteria to determine flashover is a reading of over  $20 \text{ kW/m}^2$  from a floor mounted radiometer. A radiometer was installed in the floor next to the coffee table in the approximate center of the room with a field of view toward the ceiling for all five tests. The readings from the radiometer for the two unsprinklered tests and all of the sprinklered tests are shown in figures 21 and 22, respectively; note the difference in scale on the vertical axis.

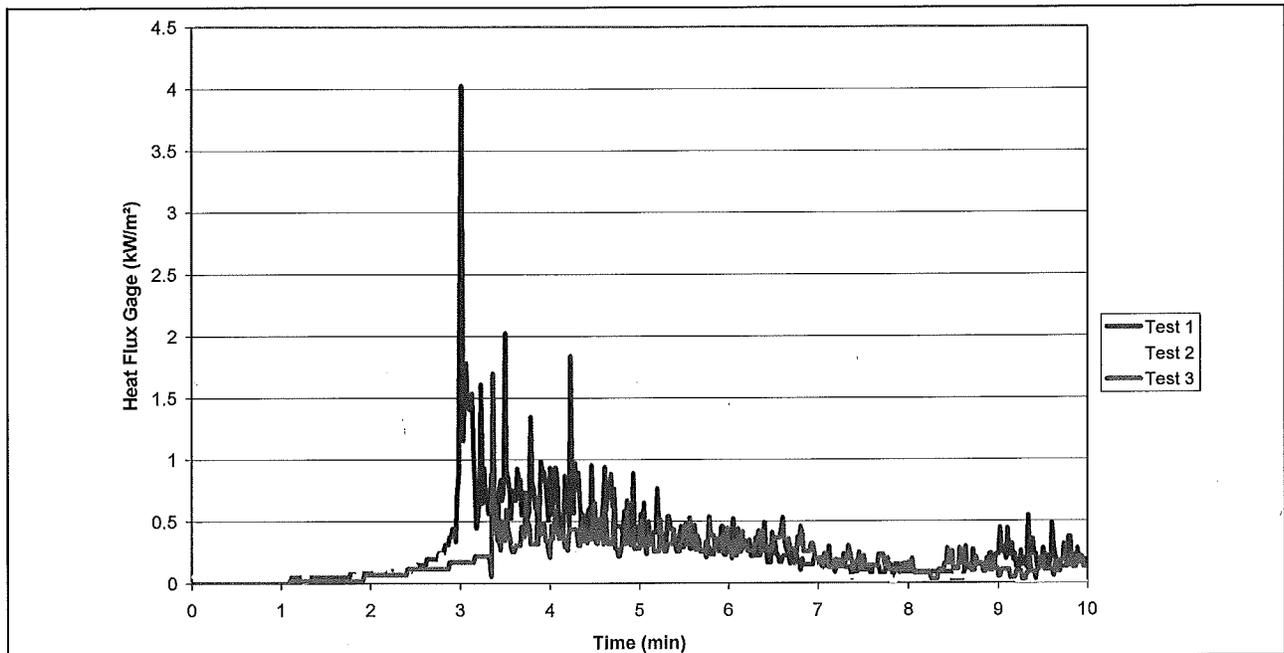
Figure 22: Reading from radiometer located on floor for all sprinklered tests

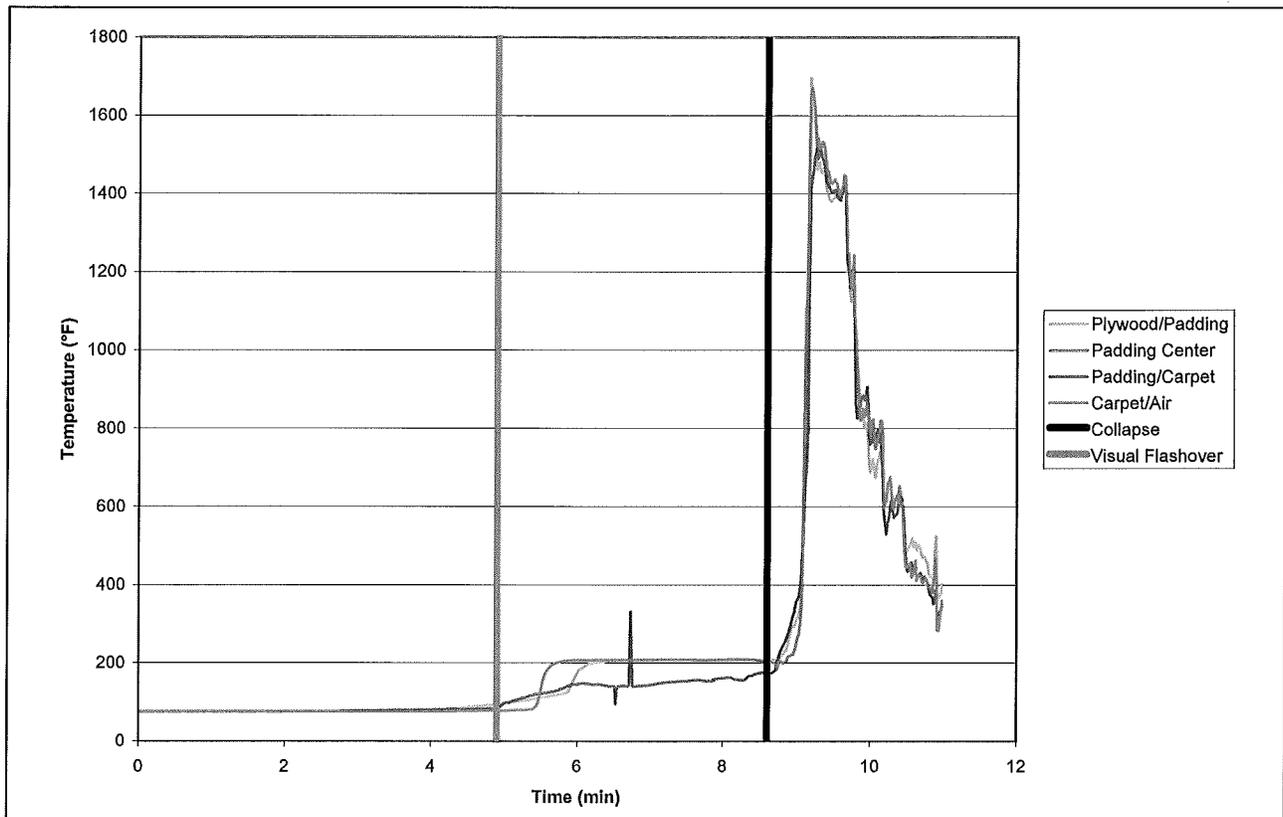
Figure 23: Ceiling/Floor assembly temperatures at the location closest to the fire

The additional instrumentation for the second freeburn test (Test 5) provided valuable information on the temperature rise through the ceiling/floor assembly. The ceiling/floor assembly temperatures did not vary significantly at the different locations (see graphs in Appendix A); the temperature traces for location 1 (closest to the fire) are shown in figure 23.

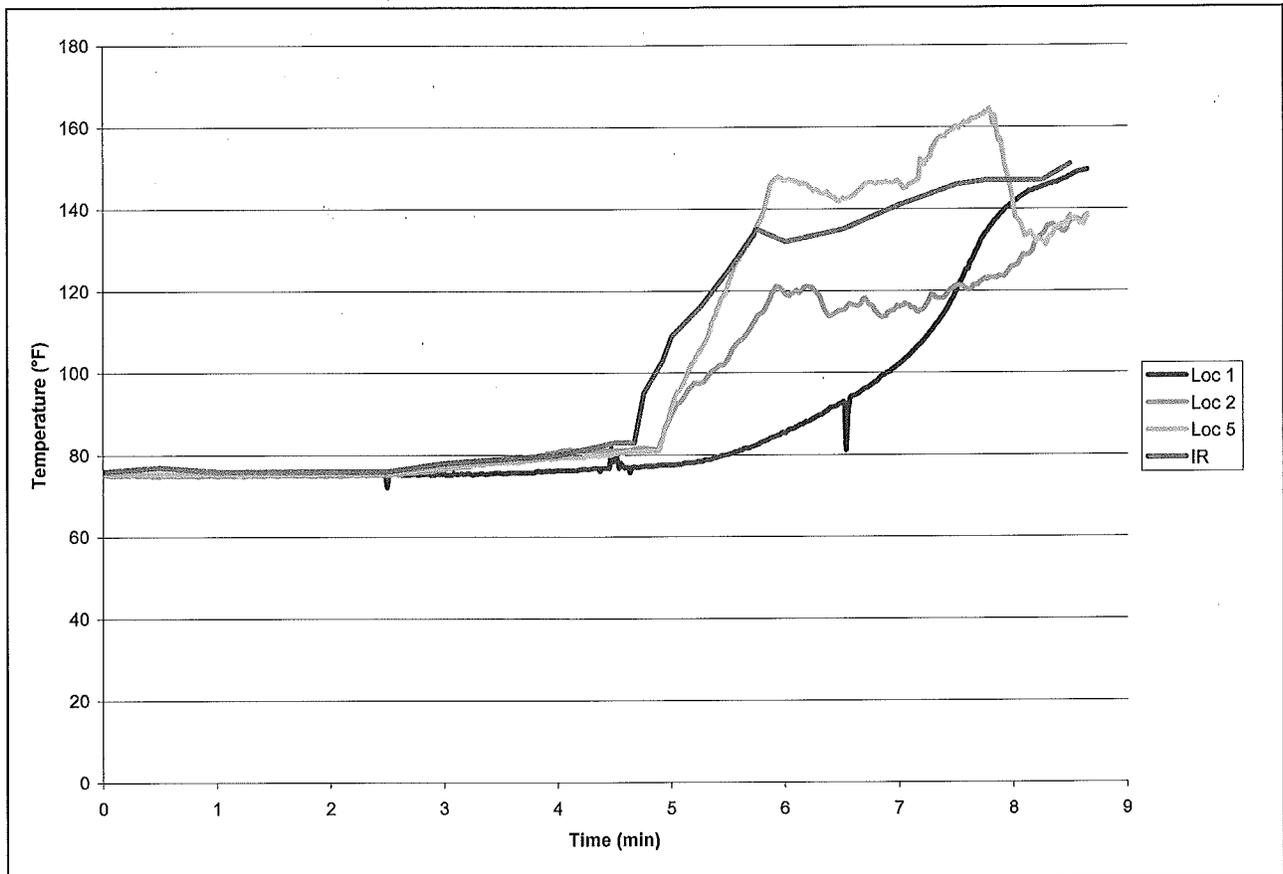
Figure 24: Comparison of temperatures recorded by the thermocouples and the thermal imaging camera on the top of the enclosure up to the point of collapse

Similar to the readings from the thermal imaging camera, the thermocouples did not report a temperature increase above ambient until after flashover and did not rise above 200°F until after collapse. The temperatures on the floor above the fire provide no indication of collapse, even immediately prior to the event.

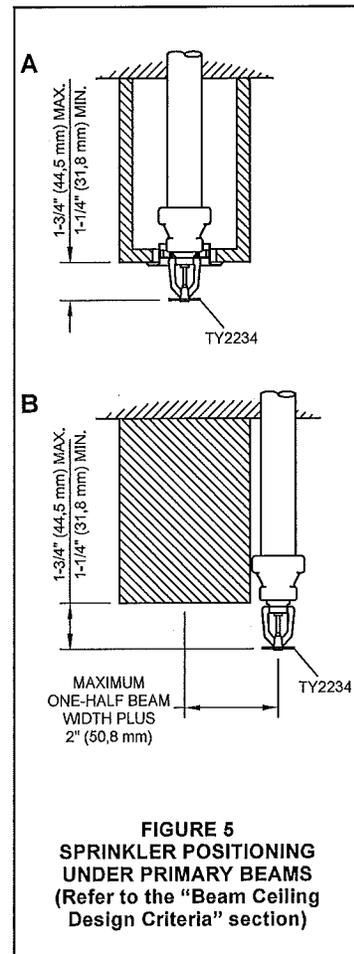
**FIGURE 5  
SPRINKLER POSITIONING  
UNDER PRIMARY BEAMS  
(Refer to the "Beam Ceiling  
Design Criteria" section)**

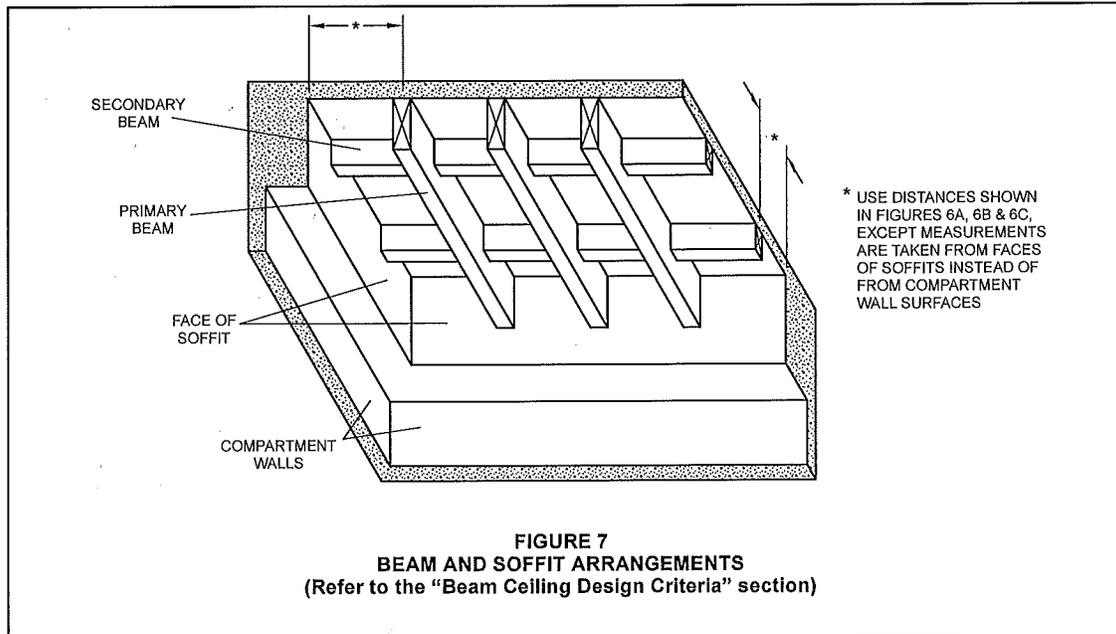
**FIGURE 7**  
**BEAM AND SOFFIT ARRANGEMENTS**  
 (Refer to the "Beam Ceiling Design Criteria" section)
